Access Compliance Report

Public Rights-of-Way (Curb Ramps)

Intersection ID: 14946	Main Street: DILWORTH_RD_WEST	Cross Street: E WORTHINGTON AV	Location:	N
ADA ID: A9EAB5F02A8E	Ramp Type: Perp	Initial Pass/Fail: Fail	Overall Compliance: No	Severity Score: 1.25

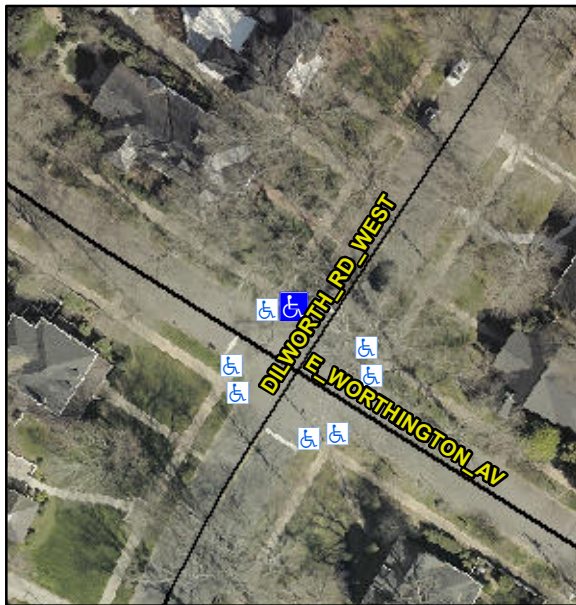
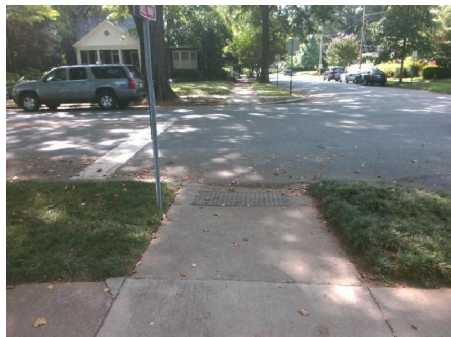
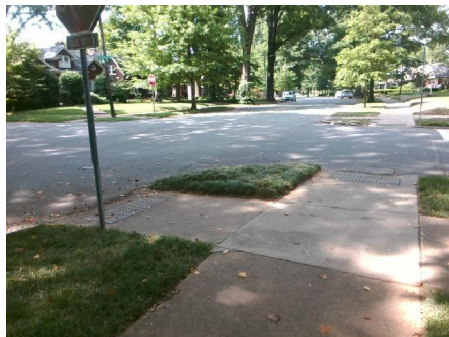
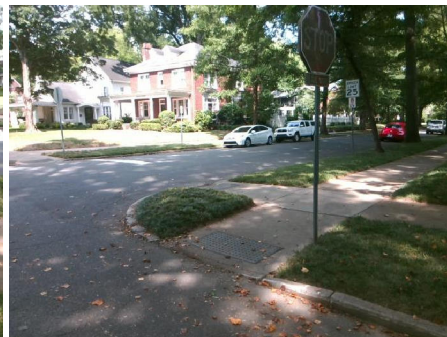
Not Found, R304.5.3

Compliance	Description	Data	Compliance	Description	Data
N/A	Ramp Length (in)	32.0	Yes	Ramp Slope (%)	5.5
Yes	Ramp Width (in)	48.0	No	Ramp XSlope (%)	3.4
N/A	Flare Type LT	N/A	N/A	Flare Type RT	N/A
N/A	Flare Slope LT (%)	N/A	N/A	Flare Slope RT (%)	N/A
N/A	Flare Traversable LT?	N/A	N/A	Flare Traversable RT?	N/A
N/A	Landing Length (in)	N/A	N/A	DWS Provided?	N/A
N/A	Landing Width (in)	N/A	N/A	DWS Contrast?	N/A
N/A	Landing Slope (%)	N/A	N/A	DWS Length (in)	N/A
N/A	Landing X Slope (%)	N/A	N/A	DWS Full Width?	N/A
N/A	Landing Curb? (Y/N)	N/A	N/A	DWS Offset (in)	N/A
N/A	Shared Landing?	N/A			
N/A	Gutter Ponding?	N/A	N/A	Gutter Slope (%)	N/A
N/A	Gutter Lip Ht (in)	N/A	N/A	Gutter X Slope (%)	N/A
N/A	Painted X Walk1?	No	N/A	Painted X Walk2?	N/A
	X Walk 1 Direction	To SE		X Walk 2 Direction	N/A
N/A	X Walk 1 Width (in)	N/A	N/A	X Walk 2 Width (in)	N/A
	X Walk 1 Slope (%)	4.2		X Walk 2 Slope (%)	N/A
	X Walk 1 X Slope (%)	1.8		X Walk 2 X Slope (%)	N/A

N/A	Ramp inside XWalk1?	N/A	N/A	Ramp inside XWalk2?	N/A
	Road Slope (%)	N/A	N/A	Clear Space?	N/A
	Road X Slope (%)	N/A	N/A	Clear Space to XWalk (in)	N/A
N/A	Any Obstructions?	N/A	N/A	Storm Grate/Utility Hazard?	N/A
	Obstruction Type			Storm Grate/Utility Type	
		N/A			N/A
			Yes	Surface Condition? (G/P)	Good

Remove & Replace Entire Ramp.

Total Cost: \$ **1850.00**
