# Access Compliance Report

## Public Rights-of-Way

### (Curb Ramps)

Intersection ID: 50240	Main Street: LONGSTONE_LN	Cross Street: CEDAR_WALK_LN	Location: SW
ADA ID: A9EF3FE8F34C	Ramp Type: Combination1Diag	Initial Pass/Fail: Fail	Overall Compliance: No
		Severity Score: 0

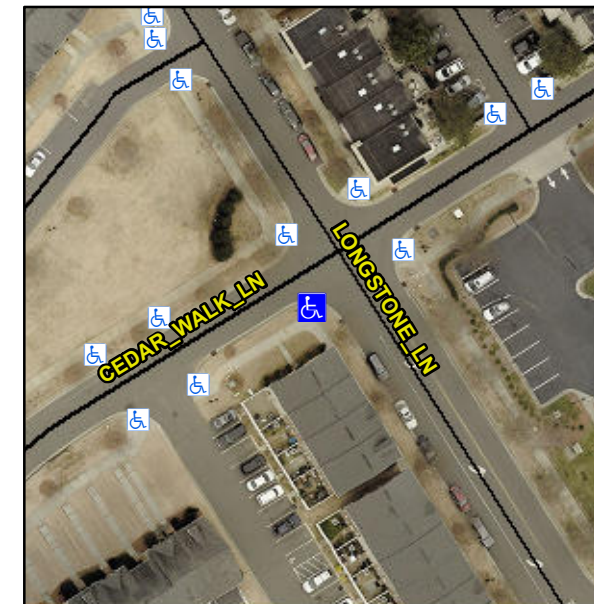
**Not Found, R304.5.1, R304.2.2, R304.5.3, R304.3.2**

Compliance	Description	Data	Compliance	Description	Data
N/A	Ramp Length LT (in)	21.5	N/A	Ramp Length RT (in)	24.0
Yes	Ramp Width LT (in)	71.0	Yes	Ramp Width RT (in)	72.0
No	Ramp Slope LT (%)	11.6	Yes	Ramp Slope RT (%)	5.5
No	Ramp XSlope LT (%)	4.4	No	Ramp XSlope RT (%)	3.4
N/A	Ramp Length (in)	92.5	No	Ramp Slope (%)	8.5
No	Ramp Width (in)	42.0	No	Ramp XSlope (%)	7.3
N/A	Flare Type LT	N/A	N/A	Flare Type RT	N/A
N/A	Flare Slope LT (%)	N/A	N/A	Flare Slope RT (%)	N/A
N/A	Flare Traversable LT?	N/A	N/A	Flare Traversable RT?	N/A
N/A	Landing Length (in)	N/A	N/A	DWS Provided?	N/A
N/A	Landing Width (in)	N/A	N/A	DWS Contrast?	N/A
N/A	Landing Slope (%)	N/A	N/A	DWS Length (in)	N/A
N/A	Landing X Slope (%)	N/A	N/A	DWS Full Width?	N/A
N/A	Landing Curb? (Y/N)	N/A	N/A	DWS Offset (in)	N/A
N/A	Shared Landing?	N/A			
N/A	Gutter Ponding?	N/A	N/A	Gutter Slope (%)	N/A
N/A	Gutter Lip Ht (in)	N/A	N/A	Gutter X Slope (%)	N/A
N/A	Painted X Walk1?	No	N/A	Painted X Walk2?	No

X Walk 1 Direction	To NE		X Walk 2 Direction	To NW
	X Walk 1 Width (in)	N/A		X Walk 2 Width (in)	N/A
	X Walk 1 Slope (%)	3.2		X Walk 2 Slope (%)	1.1
	X Walk 1 X Slope (%)	2.6		X Walk 2 X Slope (%)	2.8
N/A	Ramp inside XWalk1?	N/A	N/A	Ramp inside XWalk2?	N/A
	Road Slope (%)	3.7		Clear Space?	N/A
	Road X Slope (%)	0.9	N/A	Clear Space to XWalk (in)	N/A
			N/A	Any Obstruction?	N/A
				Obstruction Type	N/A
			N/A	Storm Grate/Utility Hazard?	N/A
				Storm Grate/Utility Type	N/A
					N/A
Yes	Surface Condition? (G/P)	Good			
	Curb Slope (%)	5.9

**Remove & Replace Curb Ramp With Two New Directional Ramps or Equivalent.**

**\$ 3200.00**
