Access Compliance Report

Public Rights-of-Way

(Curb Ramps)

Intersection ID: 46027	Main Street: BOYSENBERRY_CT	Cross Street: PAULINE_LN	Location:	NW
ADA ID: A9F77803AE3C	Ramp Type: PerpDiag	Initial Pass/Fail: Fail	Overall Compliance: No	Severity Score: 25
Codes/Mitigation Info/Possible Solution		Field Measurements/Component Compliance

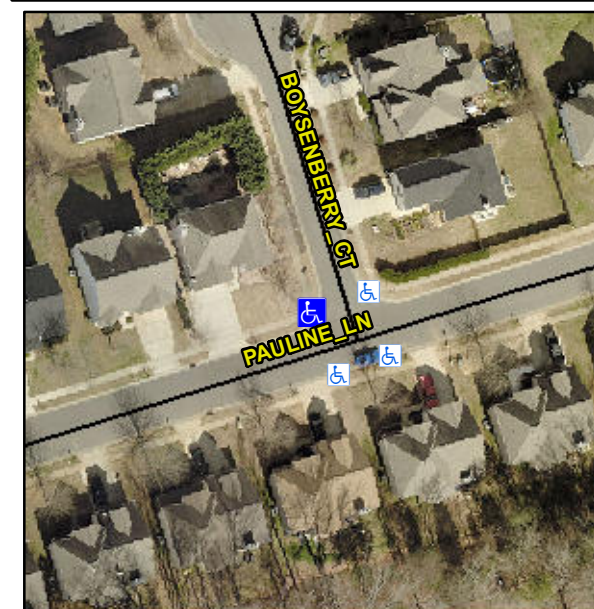
Not Found, R304.5.3

Compliance	Description	Data	Compliance	Description	Data
N/A	Ramp Length (in)	47.0	Yes	Ramp Slope (%)	6.3
Yes	Ramp Width (in)	48.0	No	Ramp XSlope (%)	7.2
N/A	Flare Type LT	N/A	N/A	Flare Type RT	N/A
N/A	Flare Slope LT (%)	N/A	N/A	Flare Slope RT (%)	N/A
N/A	Flare Traversable LT?	N/A	N/A	Flare Traversable RT?	N/A
N/A	Landing Length (in)	N/A	N/A	DWS Provided?	N/A
N/A	Landing Width (in)	N/A	N/A	DWS Contrast?	N/A
N/A	Landing Slope (%)	N/A	N/A	DWS Length (in)	N/A
N/A	Landing X Slope (%)	N/A	N/A	DWS Full Width?	N/A
N/A	Landing Curb? (Y/N)	N/A	N/A	DWS Offset (in)	N/A
N/A	Shared Landing?	N/A			
N/A	Gutter Ponding?	N/A	N/A	Gutter Slope (%)	N/A
N/A	Gutter Lip Ht (in)	N/A	N/A	Gutter X Slope (%)	N/A
N/A	Painted X Walk1?	No	N/A	Painted X Walk2?	No
	X Walk 1 Direction	To S		X Walk 2 Direction	To E
N/A	X Walk 1 Width (in)	N/A	N/A	X Walk 2 Width (in)	N/A
	X Walk 1 Slope (%)	4.5		X Walk 2 Slope (%)	3.8
	X Walk 1 X Slope (%)	4.1		X Walk 2 X Slope (%)	3.7

N/A	Ramp inside XWalk1?	N/A	N/A	Ramp inside XWalk2?	N/A
	Road Slope (%)	6.5	N/A	Clear Space?	N/A
	Road X Slope (%)	1.9	N/A	Clear Space to XWalk (in)	N/A
N/A	Any Obstructions?	N/A	N/A	Storm Grate/Utility Hazard?	N/A
	Obstruction Type			Storm Grate/Utility Type	
		N/A			N/A
		Yes		Surface Condition? (G/P)	Good

Remove & Replace Curb Ramp With Two New Directional Ramps or Equivalent.

Total Cost: \$ 3200.00
