Access Compliance Report

Public Rights-of-Way

(Curb Ramps)

Intersection ID: 48435	Main Street: BEDLINGTON_RD	Cross Street: SEAMILL_RD	Location: SE
ADA ID: A9FD537D5D84	Ramp Type: PerpDiag	Initial Pass/Fail: Fail	Overall Compliance: No
		Severity Score: 25

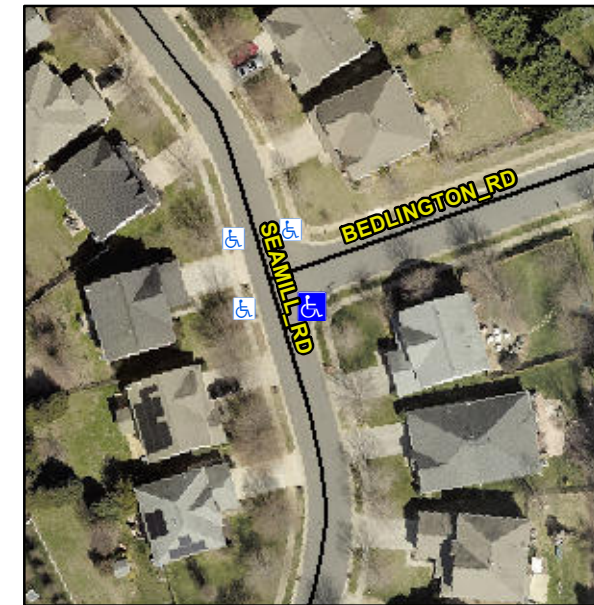
Not Found, R304.2.2, R304.5.3

Compliance	Description	Data	Compliance	Description	Data
N/A	Ramp Length (in)	48.0	No	Ramp Slope (%)	9.5
Yes	Ramp Width (in)	48.0	No	Ramp XSlope (%)	5.2
N/A	Flare Type LT	N/A	N/A	Flare Type RT	N/A
N/A	Flare Slope LT (%)	N/A	N/A	Flare Slope RT (%)	N/A
N/A	Flare Traversable LT?	N/A	N/A	Flare Traversable RT?	N/A
N/A	Landing Length (in)	N/A	N/A	DWS Provided?	N/A
N/A	Landing Width (in)	N/A	N/A	DWS Contrast?	N/A
N/A	Landing Slope (%)	N/A	N/A	DWS Length (in)	N/A
N/A	Landing X Slope (%)	N/A	N/A	DWS Full Width?	N/A
N/A	Landing Curb? (Y/N)	N/A	N/A	DWS Offset (in)	N/A
N/A	Shared Landing?	N/A			
N/A	Gutter Ponding?	N/A	N/A	Gutter Slope (%)	N/A
N/A	Gutter Lip Ht (in)	N/A	N/A	Gutter X Slope (%)	N/A
N/A	Painted X Walk1?	No	N/A	Painted X Walk2?	No
	X Walk 1 Direction	To N		X Walk 2 Direction	To W
N/A	X Walk 1 Width (in)	N/A	N/A	X Walk 2 Width (in)	N/A
	X Walk 1 Slope (%)	3.4		X Walk 2 Slope (%)	1.0
	X Walk 1 X Slope (%)	1.9		X Walk 2 X Slope (%)	3.8

N/A	Ramp inside XWalk1?	N/A	N/A	Ramp inside XWalk2?	N/A
	Road Slope (%)	1.7	N/A	Clear Space?	N/A
	Road X Slope (%)	1.2	N/A	Clear Space to XWalk (in)	N/A
N/A	Any Obstructions?	N/A	N/A	Storm Grate/Utility Hazard?	N/A
	Obstruction Type			Storm Grate/Utility Type	
		N/A			N/A
			Yes	Surface Condition? (G/P)	Good

Remove & Replace Curb Ramp With Two New Directional Ramps or Equivalent.
