Access Compliance Report

Public Rights-of-Way

(Curb Ramps)

Intersection ID: N/A	Main Street: NORTHLAKE_PLAZA_DR	Cross Street: N/A	Location: S
ADA ID: AA1B83C769CC	Ramp Type: Perp	Initial Pass/Fail: Fail	Overall Compliance: No
Severity Score: 13.75			
Codes/Mitigation Info/Possible Solution		Field Measurements/Component Compliance

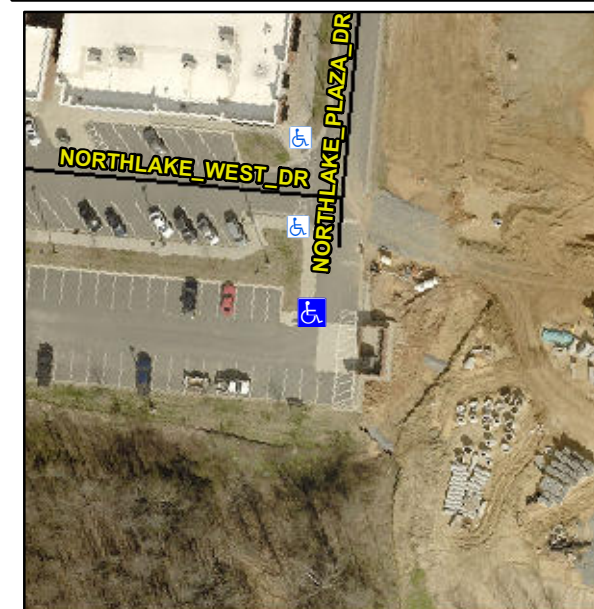
R304.2.2, R304.5.3

Compliance	Description	Data	Compliance	Description	Data
N/A	Ramp Length (in)	71.0	No	Ramp Slope (%)	9.5
Yes	Ramp Width (in)	48.0	No	Ramp XSlope (%)	3.5
N/A	Flare Type LT	N/A	N/A	Flare Type RT	N/A
N/A	Flare Slope LT (%)	N/A	N/A	Flare Slope RT (%)	N/A
N/A	Flare Traversable LT?	No	N/A	Flare Traversable RT?	No
N/A	Landing Length (in)	N/A	N/A	DWS Provided?	N/A
N/A	Landing Width (in)	N/A	N/A	DWS Contrast?	N/A
N/A	Landing Slope (%)	N/A	N/A	DWS Length (in)	N/A
N/A	Landing X Slope (%)	N/A	N/A	DWS Full Width?	N/A
N/A	Landing Curb? (Y/N)	N/A	N/A	DWS Offset (in)	N/A
N/A	Shared Landing?	N/A			
N/A	Gutter Ponding?	N/A	N/A	Gutter Slope (%)	N/A
N/A	Gutter Lip Ht (in)	N/A	N/A	Gutter X Slope (%)	N/A
N/A	Painted X Walk1?	No	N/A	Painted X Walk2?	N/A
	X Walk 1 Direction	To S		X Walk 2 Direction	N/A
N/A	X Walk 1 Width (in)	N/A	N/A	X Walk 2 Width (in)	N/A
	X Walk 1 Slope (%)	0.9		X Walk 2 Slope (%)	N/A
	X Walk 1 X Slope (%)	1.2		X Walk 2 X Slope (%)	N/A

Remove & Replace Entire Ramp.

Total Cost: \$ 1850.00
