# Access Compliance Report

## Public Rights-of-Way

### (Curb Ramps)

Intersection ID: 31910	Main Street: PALOMAR_MOUNTAIN_DR	Cross Street: STOWE_DERBY_DR	Location: SE
ADA ID: AA1ED82D3B35	Ramp Type: PerpDiag	Initial Pass/Fail: Fail	Overall Compliance: No
Severity Score: 46.25			
Codes/Mitigation Info/Possible Solution		Field Measurements/Component Compliance

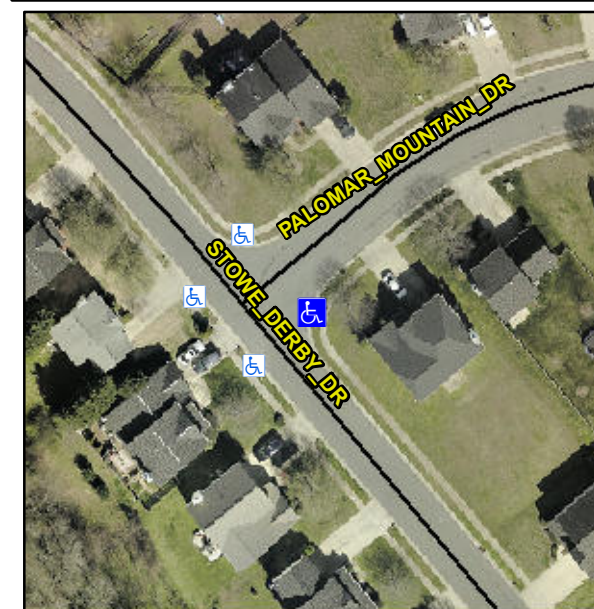
Compliance	Description	Data	Compliance	Description	Data
N/A	Ramp Length (in)	47.5	No	Ramp Slope (%)	10.2
No	Ramp Width (in)	46.5	No	Ramp XSlope (%)	8.5
N/A	Flare Type LT	N/A	N/A	Flare Type RT	N/A
N/A	Flare Slope LT (%)	N/A	N/A	Flare Slope RT (%)	N/A
N/A	Flare Traversable LT?	N/A	N/A	Flare Traversable RT?	N/A
N/A	Landing Length (in)	N/A	N/A	DWS Provided?	N/A
N/A	Landing Width (in)	N/A	N/A	DWS Contrast?	N/A
N/A	Landing Slope (%)	N/A	N/A	DWS Length (in)	N/A
N/A	Landing X Slope (%)	N/A	N/A	DWS Full Width?	N/A
N/A	Landing Curb? (Y/N)	N/A	N/A	DWS Offset (in)	N/A
N/A	Shared Landing?	N/A			
N/A	Gutter Ponding?	N/A	N/A	Gutter Slope (%)	N/A
N/A	Gutter Lip Ht (in)	N/A	N/A	Gutter X Slope (%)	N/A
N/A	Painted X Walk1?	No	N/A	Painted X Walk2?	No
	X Walk 1 Direction	To NW		X Walk 2 Direction	To SW
N/A	X Walk 1 Width (in)	N/A	N/A	X Walk 2 Width (in)	N/A
	X Walk 1 Slope (%)	3.4		X Walk 2 Slope (%)	2.8
	X Walk 1 X Slope (%)	6.7		X Walk 2 X Slope (%)	3.7

N/A	Ramp inside XWalk1?	N/A	N/A	Ramp inside XWalk2?	N/A
	Road Slope (%)	7.6	N/A	Clear Space?	N/A
	Road X Slope (%)	2.3	N/A	Clear Space to XWalk (in)	N/A
N/A	Any Obstructions?	N/A	N/A	Storm Grate/Utility Hazard?	N/A
	Obstruction Type			Storm Grate/Utility Type	
		N/A			N/A
			Yes	Surface Condition? (G/P)	Good

Possible Solutions:

**Remove & Replace Curb Ramp With Two New Directional Ramps or Equivalent.**

**R304.5.1, R304.2.2, R304.5.3**
