# Access Compliance Report

## Public Rights-of-Way

### (Curb Ramps)

Intersection ID: 10027726	Main Street: GRIFFITH_RD	Cross Street: N/A	Location:	N
ADA ID: AA28BC3D6E97	Ramp Type: PerpDiag	Initial Pass/Fail: Fail	Overall Compliance: No	Severity Score: 22.5

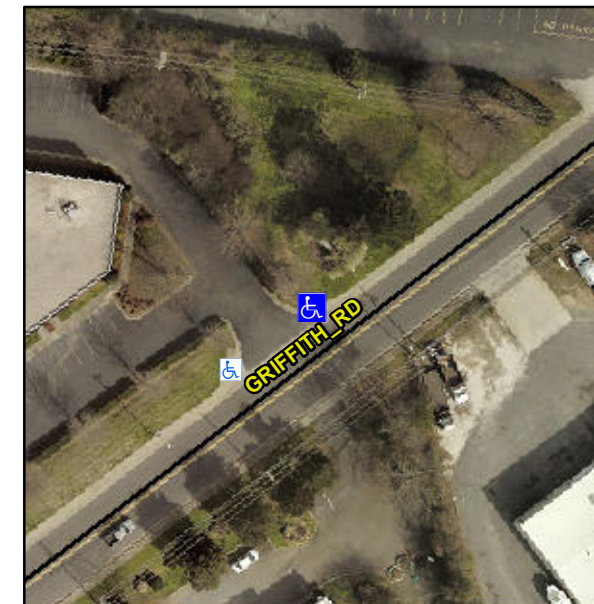
**R304.5.1, R304.2.2, R304.5.3**

Compliance	Description	Data	Compliance	Description	Data
N/A	Ramp Length (in)	60.0	No	Ramp Slope (%)	10.7
No	Ramp Width (in)	47.5	No	Ramp XSlope (%)	2.4
N/A	Flare Type LT	N/A	N/A	Flare Type RT	N/A
N/A	Flare Slope LT (%)	N/A	N/A	Flare Slope RT (%)	N/A
N/A	Flare Traversable LT?	N/A	N/A	Flare Traversable RT?	N/A
N/A	Landing Length (in)	N/A	N/A	DWS Provided?	N/A
N/A	Landing Width (in)	N/A	N/A	DWS Contrast?	N/A
N/A	Landing Slope (%)	N/A	N/A	DWS Length (in)	N/A
N/A	Landing X Slope (%)	N/A	N/A	DWS Full Width?	N/A
N/A	Landing Curb? (Y/N)	N/A	N/A	DWS Offset (in)	N/A
N/A	Shared Landing?	N/A			
N/A	Gutter Ponding?	N/A	N/A	Gutter Slope (%)	N/A
N/A	Gutter Lip Ht (in)	N/A	N/A	Gutter X Slope (%)	N/A
N/A	Painted X Walk1?	No	N/A	Painted X Walk2?	No
	X Walk 1 Direction	To SW		X Walk 2 Direction	To SE
N/A	X Walk 1 Width (in)	N/A	N/A	X Walk 2 Width (in)	N/A
	X Walk 1 Slope (%)	3.7		X Walk 2 Slope (%)	2.1
	X Walk 1 X Slope (%)	0.7		X Walk 2 X Slope (%)	3.1

N/A	Ramp inside XWalk1?	N/A	N/A	Ramp inside XWalk2?	N/A
	Road Slope (%)	1.9	N/A	Clear Space?	N/A
	Road X Slope (%)	2.2	N/A	Clear Space to XWalk (in)	N/A
N/A	Any Obstructions?	N/A	N/A	Storm Grate/Utility Hazard?	N/A
	Obstruction Type			Storm Grate/Utility Type	
		N/A			N/A
			Yes	Surface Condition? (G/P)	Good

**Remove & Replace Curb Ramp With Two New Directional Ramps or Equivalent.**

Total Cost: \$ 3200.00
