Access Compliance Report

Public Rights-of-Way

(Curb Ramps)

Intersection ID: 15025	Main Street: DWIGHTWARE_BV	Cross Street: HEMSWORTH_TR	Location: NW
ADA ID: AA29F2B5D61F	Ramp Type: Directional1	Initial Pass/Fail: Fail	Overall Compliance: No
Severity Score: 25			
Codes/Mitigation Info/Possible Solution		Field Measurements/Component Compliance

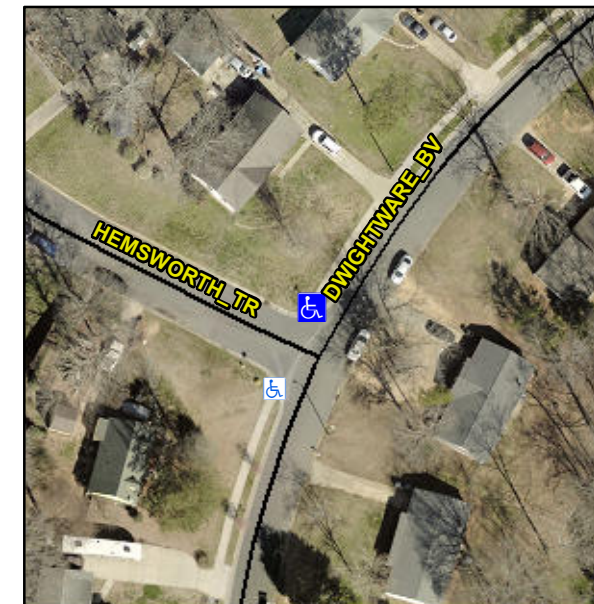
R304.2.2

Compliance	Description	Data	Compliance	Description	Data
N/A	Ramp Length (in)	48.0	N/A	Grade Break?	N/A
Yes	Ramp Width (in)	48.0	N/A	Grade Break Slope (%)	0.0
No	Ramp Slope (%)	12.4	N/A	Grade Break XSlope (%)	0.0
Yes	Ramp XSlope (%)	1.9			
N/A	Flare Type LT	N/A	N/A	Flare Type RT	N/A
N/A	Flare Slope LT (%)	N/A	N/A	Flare Slope RT (%)	0.0
N/A	Flare Traversable LT?	N/A	N/A	Flare Traversable RT?	N/A
N/A	Landing Length (in)	0.0	N/A	DWS Provided?	N/A
N/A	Landing Width (in)	0.0	N/A	DWS Contrast?	N/A
N/A	Landing Slope (%)	0.0	N/A	DWS Length (in)	N/A
N/A	Landing X Slope (%)	0.0	N/A	DWS Full Width?	N/A
N/A	Landing Curb? (Y/N)	N/A	N/A	DWS Offset LT (in)	N/A
N/A	Shared Landing?	N/A	N/A	DWS Offset RT (in)	N/A
N/A	Gutter Ponding?	0.0	N/A	Gutter Slope (%)	N/A
N/A	Gutter Lip Ht (in)	0.0	N/A	Gutter X Slope (%)	N/A
N/A	Painted X Walk1?	No		Road Slope (%)	5.4
	X Walk 1 Direction	To S		Road X Slope (%)	4.5
	X Walk 1 Width (in)	N/A		Clear Space?	N/A

X Walk 1 Slope (%)	5.4	N/A	Clear Space to XWalk (in)	N/A
	X Walk 1 X Slope (%)	4.5	N/A	Storm Grate/Utility Hazard?	N/A
N/A	Ramp inside XWalk1?	N/A		Storm Grate/Utility Type	
N/A	Any Obstructions?	N/A			N/A
	Obstruction Type		Yes	Surface Condition? (G/P)	Good
			N/A	Curb Slope (%)	10.0

Possible Solutions:

Remove & Replace Entire Ramp.
