Access Compliance Report

Public Rights-of-Way

(Curb Ramps)

Intersection ID: 14672	Main Street: NORFOLK_AV	Cross Street: REMOUNT_RD	Location: W
ADA ID: AA32F22DCB41	Ramp Type: PerpDiag	Initial Pass/Fail: Fail	Overall Compliance: No
Codes/Mitigation Info/Possible Solution		Field Measurements/Component Compliance	
Severity Score: 28.75

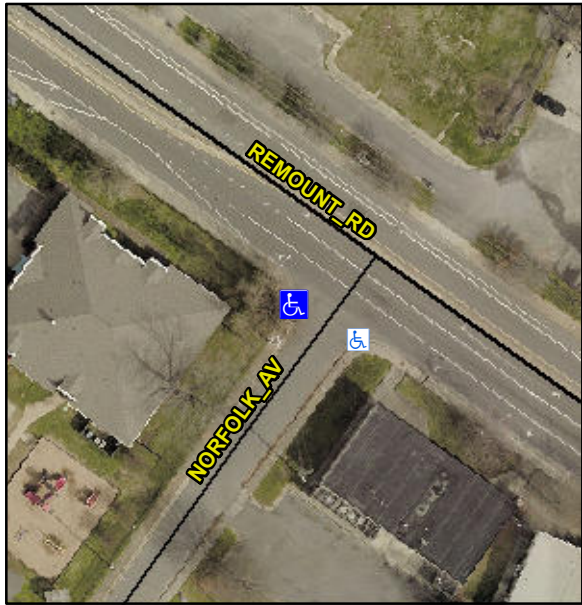
Possible Solutions:			Compliance			Description			Data	Compliance			Description			Data
	Remove & Replace Curb Ramp With Two New Directional Ramps or Equivalent.			N/A	Ramp Length (in)			59.0	No	Ramp Slope (%)			10.2				
				Yes	Ramp Width (in)			48.0	No	Ramp XSlope (%)			3.7				
				N/A	Flare Type LT			N/A	N/A	Flare Type RT			N/A				
				N/A	Flare Slope LT (%)			N/A	N/A	Flare Slope RT (%)			N/A				
				N/A	Flare Traversable LT?			N/A	N/A	Flare Traversable RT?			N/A				
				N/A	Landing Length (in)			N/A	N/A	DWS Provided?			N/A				
				N/A	Landing Width (in)			N/A	N/A	DWS Contrast?			N/A				
				N/A	Landing Slope (%)			N/A	N/A	DWS Length (in)			N/A				
				N/A	Landing X Slope (%)			N/A	N/A	DWS Full Width?			N/A				
Surveyor Notes:			N/A	Landing Curb? (Y/N)			N/A	N/A	DWS Offset (in)			N/A					
PROW/ADA:				Shared Landing?			N/A										
R304.2.2, R304.5.3, R302.7			N/A	Gutter Ponding?			N/A	N/A	Gutter Slope (%)			N/A

N/A	Gutter Lip Ht (in)			N/A	N/A	Gutter X Slope (%)			N/A					
			N/A	Painted X Walk1?			No	N/A	Painted X Walk2?			No					
				X Walk 1 Direction			To SE		X Walk 2 Direction			To NE					
			N/A	X Walk 1 Width (in)			N/A	N/A	X Walk 2 Width (in)			N/A					
				X Walk 1 Slope (%)			3.9		X Walk 2 Slope (%)			0.1					
				X Walk 1 X Slope (%)			2.0		X Walk 2 X Slope (%)			4.0					
Street 1 Name			NORFOLK AV	Ramp inside XWalk1?			N/A	N/A	Ramp inside XWalk2?			N/A					
Stop Condition-Street 2			StopSign	Road Slope (%)			6.2	N/A	Clear Space?			N/A					
Street 2 Name			REMOUNT RD	Road X Slope (%)			3.1	N/A	Clear Space to XWalk (in)			N/A					
Stop Condition-Street 1			None	Any Obstructions?			N/A	N/A	Storm Grate/Utility Hazard?			N/A					
				Obstruction Type					Storm Grate/Utility Type								
							N/A					N/A					
							No		Surface Condition? (G/P)			Poor
