# Access Compliance Report

## Public Rights-of-Way

### (Curb Ramps)

Intersection ID: 11264	Main Street: N_PINE_ST	Cross Street: W_12TH_ST	Location: E
ADA ID: AA335D0B25BE	Ramp Type: Combination2	Initial Pass/Fail: Fail	Overall Compliance: No
			Severity Score: 21.25

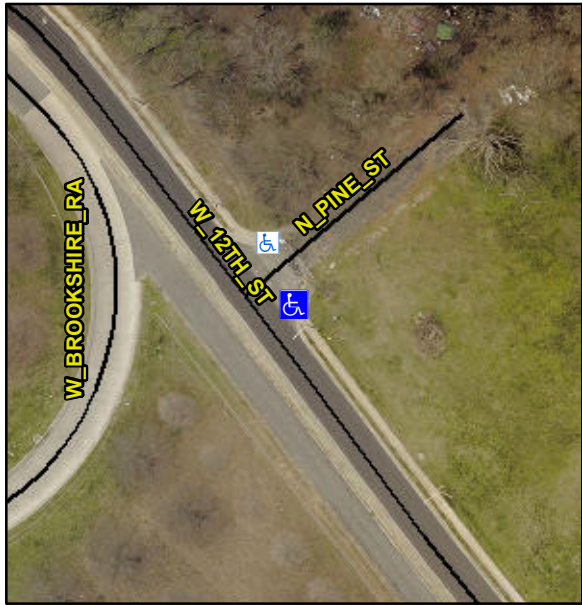
Possible Solutions:			<b>Compliance</b>	<b>Description</b>	<b>Data</b>	<b>Compliance</b>	<b>Description</b>	<b>Data</b>		
	<b>Remove &amp; Replace Entire Ramp.</b>			N/A	Ramp Length LT (in)	49.5	N/A	Ramp Length RT (in)	58.5		
				N/A	Ramp Width LT (in)	39.0	No	Ramp Width RT (in)	38.0		
				N/A	Ramp Slope LT (%)	1.6	Yes	Ramp Slope RT (%)	6.9		
				N/A	Ramp XSlope LT (%)	6.4	No	Ramp XSlope RT (%)	3.8		
				N/A	Ramp Length (in)	22.0	Yes	Ramp Slope (%)	7.6		
				No	Ramp Width (in)	44.0	Yes	Ramp XSlope (%)	2.2		
				N/A	Flare Type LT	N/A	N/A	Flare Type RT	N/A		
				N/A	Flare Slope LT (%)	N/A	N/A	Flare Slope RT (%)	N/A		
				N/A	Flare Traversable LT?	N/A	N/A	Flare Traversable RT?	N/A		
Surveyor Notes:			N/A	Landing Length (in)	N/A	N/A	DWS Provided?	N/A			
<b>LT RP &lt; 5%</b>			N/A	Landing Width (in)	N/A	N/A	DWS Contrast?	N/A

PROW/ADA:			N/A	Landing Slope (%)	N/A	N/A	DWS Length (in)	N/A			
<b>Not Found, R304.5.1, R304.5.1, R304.5.3</b>			N/A	Landing X Slope (%)	N/A	N/A	DWS Full Width?	N/A			
			N/A	Landing Curb? (Y/N)	N/A	N/A	DWS Offset (in)	N/A			
			N/A	Shared Landing?	N/A						
			N/A	Gutter Ponding?	N/A	N/A	Gutter Slope (%)	N/A			
			N/A	Gutter Lip Ht (in)	N/A	N/A	Gutter X Slope (%)	N/A			
			N/A	Painted X Walk1?	No	N/A	Painted X Walk2?	N/A			
				X Walk 1 Direction	To NW		X Walk 2 Direction	N/A			
				X Walk 1 Width (in)	N/A		X Walk 2 Width (in)	N/A			
				X Walk 1 Slope (%)	0.6		X Walk 2 Slope (%)	N/A			
				X Walk 1 X Slope (%)	2.4		X Walk 2 X Slope (%)	N/A			
			N/A	Ramp inside XWalk1?	N/A	N/A	Ramp inside XWalk2?	N/A			
				Road Slope (%)	N/A		Clear Space?	N/A			
				Road X Slope (%)	N/A	N/A	Clear Space to XWalk (in)	N/A			
						N/A	Any Obstruction?	N/A			
							Obstruction Type	N/A			
								N/A			
						N/A	Storm Grate/Utility Hazard?	N/A

Storm Grate/Utility Type	N/A			
								N/A			
			Yes	Surface Condition? (G/P)				Good			
				Curb Slope (%)				24.1			
Street 1 Name				None							
Stop Condition-Street 1				PINE ST							
Street 2 Name				N/A							
Stop Condition-Street 2				N/A							
Total Cost:				\$	1600.00

**LT RP < 5%**

**Not Found, R304.5.1, R304.5.1, R304.5.3**

**Remove & Replace Entire Ramp.**
