# Access Compliance Report

## Public Rights-of-Way (Curb Ramps)

| Intersection ID: 14281 | Main Street: E_KINGSTON_AV | Cross Street: LYNDHURST_AV | Location: | S |
| ADA ID: AA34C36301DF | Ramp Type: Directional1 | Initial Pass/Fail: Pass | Overall Compliance: No | Severity Score: 20 |

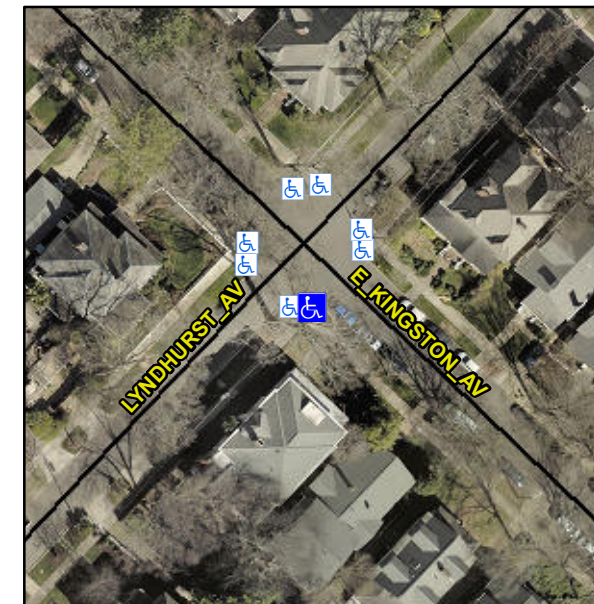
**R304.5.2, R302.7, R302.7.2, R304.5.4**

| Compliance | Description | Data | Compliance | Description | Data |
|---|---|---|---|---|---|
| No | Gutter Ponding? | Yes | No | Gutter Slope (%) | 7.7 |
| No | Gutter Lip Ht (in) | 1.0 | Yes | Gutter X Slope (%) | 0.6 |

**Remove & Replace Entire Ramp.  
Remove & Replace Gutter.**
