Intersection ID: 44300	Main Street: ROCKWOOD_RD	Cross Street: CRANDON_DR	Location:	SW
ADA ID: AA3EBDB35A99	Ramp Type: BlendTrans1	Initial Pass/Fail: Fail	Overall Compliance: No	Severity Score: 18.75

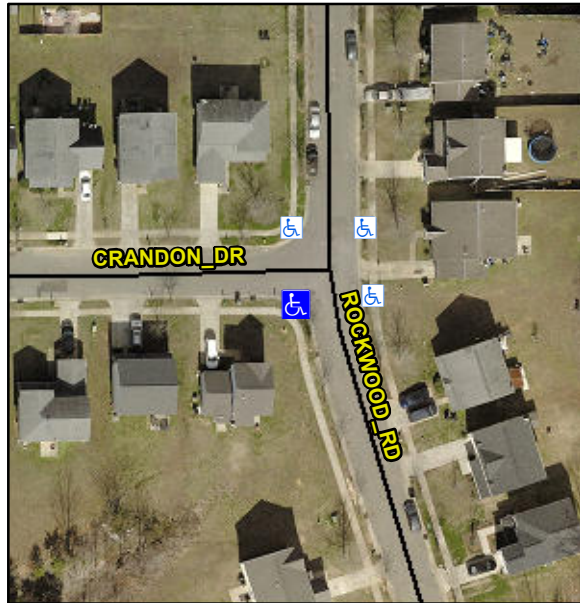
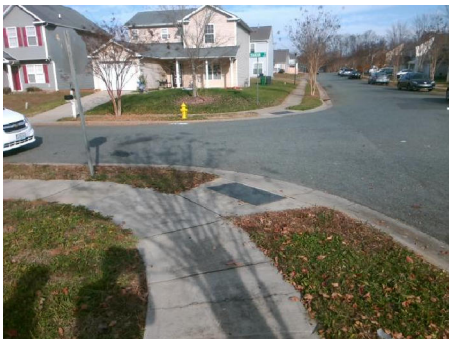
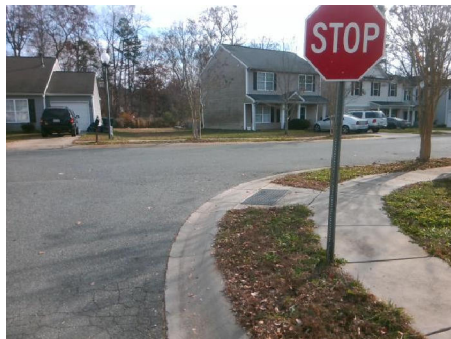
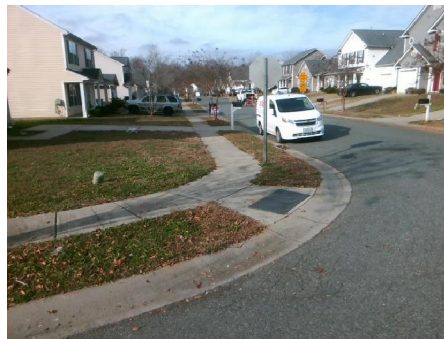
Not Found, R304.5.1, R304.5.3

Compliance	Description	Data	Compliance	Description	Data
N/A	Ramp Length (in)	53.0	Yes	BlendTrans Slope (%)	3.1
No	Ramp Width (in)	35.5	No	BlendTrans XSlope (%)	2.2
N/A	Flare Type LT	N/A	N/A	Flare Type RT	N/A
N/A	Flare Slope LT (%)	N/A	N/A	Flare Slope RT (%)	N/A
N/A	Flare Traversable LT?	N/A	N/A	Flare Traversable RT?	N/A
N/A	Landing Length (in)	N/A	N/A	DWS Provided?	N/A
N/A	Landing Width (in)	N/A	N/A	DWS Contrast?	N/A
N/A	Landing Slope (%)	N/A	N/A	DWS Length (in)	N/A
N/A	Landing X Slope (%)	N/A	N/A	DWS Full Width?	N/A
N/A	Landing Curb? (Y/N)	N/A	N/A	DWS Offset (in)	N/A
N/A	Shared Landing?	N/A			
N/A	Gutter Ponding?	N/A	N/A	Gutter Slope (%)	N/A
N/A	Gutter Lip Ht (in)	N/A	N/A	Gutter X Slope (%)	N/A
N/A	Painted X Walk1?	No	N/A	Painted X Walk2?	No
	X Walk 1 Direction	To E		X Walk 2 Direction	To N
	X Walk 1 Width (in)	N/A		X Walk 2 Width (in)	N/A
	X Walk 1 Slope (%)	4.5		X Walk 2 Slope (%)	3.8
	X Walk 1 X Slope (%)	1.8		X Walk 2 X Slope (%)	3.0

N/A	Ramp inside XWalk1?	N/A	N/A	Ramp inside XWalk2?	N/A
	Road Slope (%)	0.1		Clear Space?	N/A
	Road X Slope (%)	6.1	N/A	Clear Space to XWalk (in)	N/A
N/A	Any Obstructions?	N/A	N/A	Storm Grate/Utility Hazard?	N/A
	Obstruction Type			Storm Grate/Utility Type	
		N/A			N/A
			Yes	Surface Condition? (G/P)	Good
			No	Curb Slope (%)	12.9

Remove & Replace Curb Ramp With Two New Directional Ramps or Equivalent.
