## **Access Compliance Report Public Rights-of-Way** (Curb Ramps)

Intersection ID: 18958 Main Street: GROVER RD **Cross Street: OLD PINEVILLE RD** Location: SE **ADA ID: AA3EF3563BB1** Ramp Type: Perp Initial Pass/Fail: Pass **Overall Compliance: No Severity Score:**

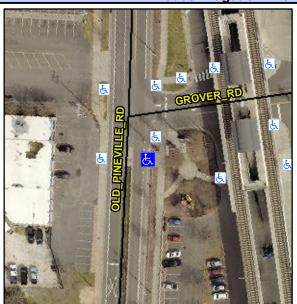
Field Measurements/Component Compliance					
Compliance Description Data		Comp	liance Description	Data	
N/A	Ramp Length (in)	97.0	Yes	Ramp Slope (%)	7.2
Yes	Ramp Width (in)	48.0	Yes	Ramp XSlope (%)	1.5
N/A	Flare Type LT	Sloped	N/A	Flare Type RT	N/A
N/A	Flare Slope LT (%)	3.6	Yes	Flare Slope RT (%)	5.7
N/A	Flare Traversable LT?	Yes	N/A	Flare Traversable RT?	Yes
Yes	Landing Length (in)	95.0	Yes	DWS Provided?	Yes
Yes	Landing Width (in)	60.0	Yes	DWS Contrast?	Yes
Yes	Landing Slope (%)	2.0	Yes	DWS Length (in)	24.0
Yes	Landing X Slope (%)	0.7	Yes	DWS Full Width?	Yes
N/A	Landing Curb? (Y/N)	No	Yes	DWS Offset (in)	1.0
N/A	Shared Landing?	No			
Yes	Gutter Ponding?	No	Yes	Gutter Slope (%)	3.4
Yes	Gutter Lip Ht (in)	0.0	No	Gutter X Slope (%)	4.0
N/A	Painted X Walk1?	No	N/A	Painted X Walk2?	N/A
	X Walk 1 Direction	To W		X Walk 2 Direction	N/A
N/A	X Walk 1 Width (in)	N/A	N/A	X Walk 2 Width (in)	N/A
	X Walk 1 Slope (%)	3.4		X Walk 2 Slope (%)	N/A

X Walk 1 X Slope (%)	1.0		X Walk 2 X Slope (%)	N/A
N/A	Ramp inside XWalk1?	N/A	N/A	Ramp inside XWalk2?	N/A
	Road Slope (%)	N/A	N/A	Clear Space?	Yes
	Road X Slope (%)	N/A	N/A	Clear Space to XWalk (in)	N/A
Yes	Any Obstructions?	No	Yes	Storm Grate/Utility Hazard?	No
	Obstruction Type			Storm Grate/Utility Type	
		N/A			N/A
			Yes	Surface Condition? (G/P)	Good

**OLD PINEVILLE RD** Street 1 Name Stop Condition-Street 2 None Street 2 Name N/A Stop Condition-Street 1 N/A Possible Solutions: Remove & Replace Entire Ramp. Remove & Replace Gutter. Surveyor Notes: N/A PROW/ADA: Not Found, R304.5.3
