Access Compliance Report

Public Rights-of-Way

(Curb Ramps)

Intersection ID: 21085	Main Street: LARKFIELD_LN	Cross Street: WOODSTREAM_DR	Location: SW
ADA ID: AA412CBB8CCD	Ramp Type: Combination1	Initial Pass/Fail: Fail	Overall Compliance: No
			Severity Score: 33.75

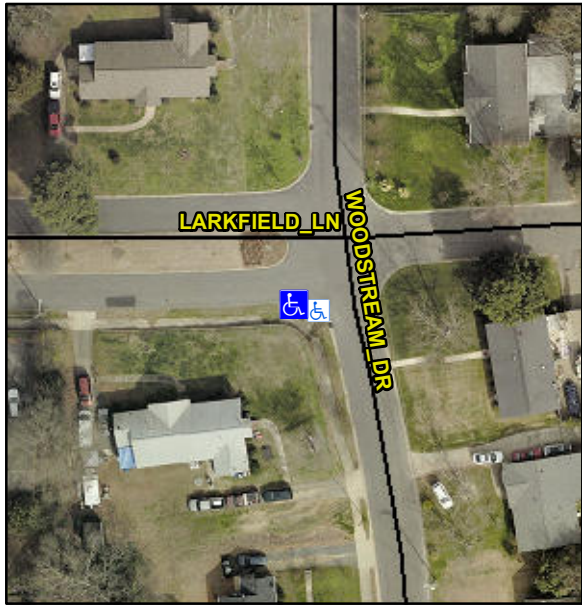
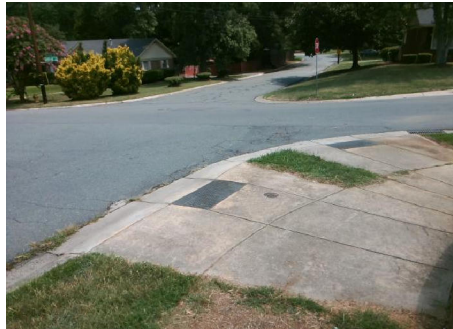
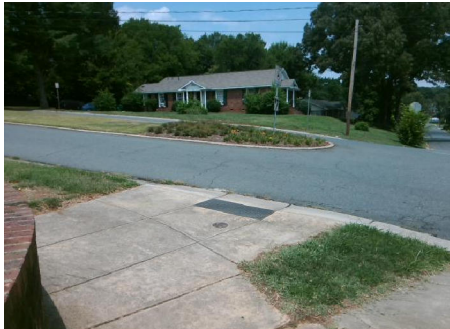
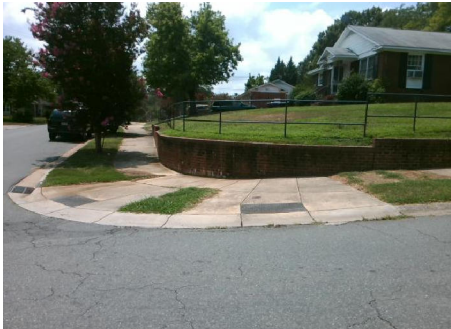
Possible Solutions:			Compliance	Description	Data	Compliance	Description	Data
	Remove & Replace Entire Ramp.			N/A	Ramp Length LT (in)	25.0	N/A	Ramp Length RT (in)	49.0
				Yes	Ramp Width LT (in)	72.0	Yes	Ramp Width RT (in)	72.0
				No	Ramp Slope LT (%)	9.5	No	Ramp Slope RT (%)	9.2
				No	Ramp XSlope LT (%)	2.2	No	Ramp XSlope RT (%)	4.4
				N/A	Ramp Length (in)	59.0	Yes	Ramp Slope (%)	5.1
				No	Ramp Width (in)	43.0	No	Ramp XSlope (%)	6.8
	Surveyor Notes:			N/A	Flare Type LT	N/A	N/A	Flare Type RT	N/A
	N/A			N/A	Flare Slope LT (%)	N/A	N/A	Flare Slope RT (%)	N/A
				N/A	Flare Traversable LT?	N/A	N/A	Flare Traversable RT?	N/A

PROW/ADA:			N/A	Landing Length (in)	N/A	N/A	DWS Provided?	N/A
	Not Found, R304.5.1, R304.5.3, R304.3.2			N/A	Landing Width (in)	N/A	N/A	DWS Contrast?	N/A
				N/A	Landing Slope (%)	N/A	N/A	DWS Length (in)	N/A

X Walk 1 Width (in)	N/A		X Walk 2 Width (in)	N/A
					X Walk 1 Slope (%)	2.7		X Walk 2 Slope (%)	N/A
					X Walk 1 X Slope (%)	6.7		X Walk 2 X Slope (%)	N/A
				N/A	Ramp inside XWalk1?	N/A	N/A	Ramp inside XWalk2?	N/A
					Road Slope (%)	N/A		Clear Space?	N/A
					Road X Slope (%)	N/A	N/A	Clear Space to XWalk (in)	N/A
							N/A	Any Obstruction?	N/A
								Obstruction Type	N/A
							N/A	Storm Grate/Utility Hazard?	N/A
								Storm Grate/Utility Type	N/A

Yes	Surface Condition? (G/P)				Good
					Curb Slope (%)				14.7
