Access Compliance Report Public Rights-of-Way (Curb Ramps)

Intersection ID: 50603 Main Street: RHODORA_RD Cross Street: EMPRESS_CT Location: SE

ADA ID: AA42064DB47F Ramp Type: Perp Initial Pass/Fail: Fail Overall Compliance: No Severity Score: 8.75

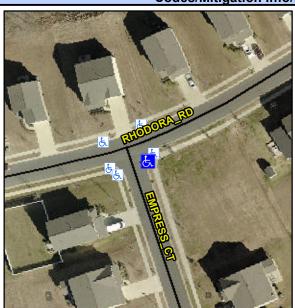
Compliance Description Data Compliance Description Data Yes N/A Ramp Length (in) 47.0 Ramp Slope (%) 5.9 Yes Ramp XSlope (%) No Ramp Width (in) 47.5 0.7 N/A N/A Flare Type LT N/A Flare Type RT N/A N/A N/A N/A Flare Slope RT (%) N/A Flare Slope LT (%) N/A Flare Traversable LT? N/A N/A Flare Traversable RT? N/A N/A N/A N/A DWS Provided? N/A Landing Length (in) N/A Landing Width (in) N/A N/A **DWS Contrast?** N/A N/A N/A N/A Landing Slope (%) DWS Length (in) N/A N/A Landing X Slope (%) N/A N/A DWS Full Width? N/A N/A Landing Curb? (Y/N) N/A N/A DWS Offset (in) N/A N/A N/A Shared Landing? N/A **Gutter Ponding?** N/A N/A Gutter Slope (%) N/A N/A Gutter Lip Ht (in) N/A N/A Gutter X Slope (%) N/A N/A Painted X Walk1? No N/A Painted X Walk2? N/A X Walk 1 Direction To W X Walk 2 Direction N/A N/A N/A N/A X Walk 2 Width (in) X Walk 1 Width (in) N/A X Walk 1 Slope (%) 0.3 X Walk 2 Slope (%) N/A X Walk 1 X Slope (%) 2.2 X Walk 2 X Slope (%) N/A N/A N/A N/A Ramp inside XWalk2? Ramp inside XWalk1? N/A Road Slope (%) N/A N/A Clear Space? N/A N/A Road X Slope (%) N/A Clear Space to XWalk (in) N/A N/A N/A Any Obstructions? N/A Storm Grate/Utility Hazard? N/A **Obstruction Type** Storm Grate/Utility Type N/A N/A Yes Surface Condition? (G/P) Good

Possible Solutions:

Remove & Replace Entire Ramp.
