Access Compliance Report

Public Rights-of-Way

(Curb Ramps)

Intersection ID: 10776	Main Street: CAROL_AV	Cross Street: STATE_ST	Location: W
ADA ID: AA49F7C3CADC	Ramp Type: Perp	Initial Pass/Fail: Fail	Overall Compliance: No
		Severity Score: 25

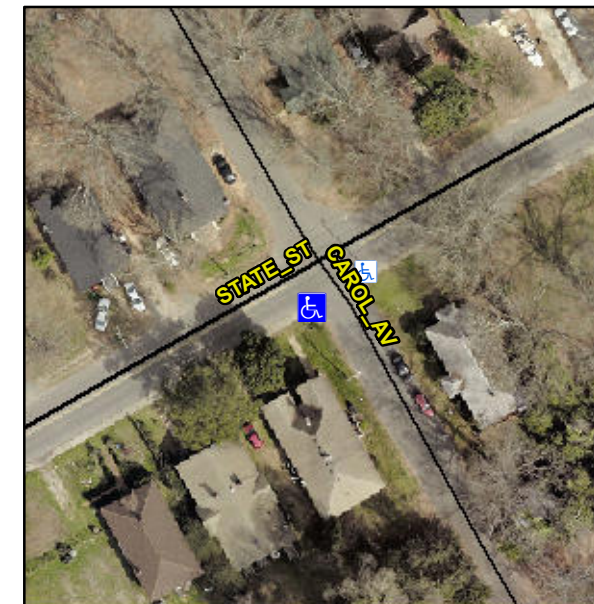
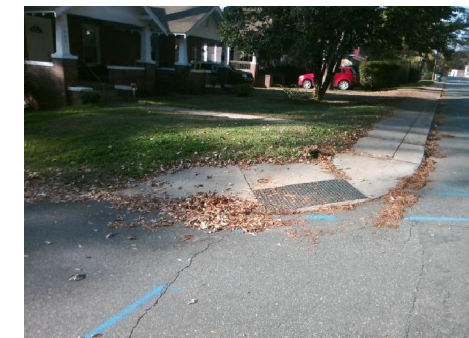
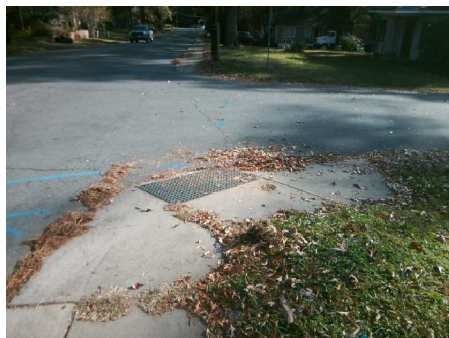
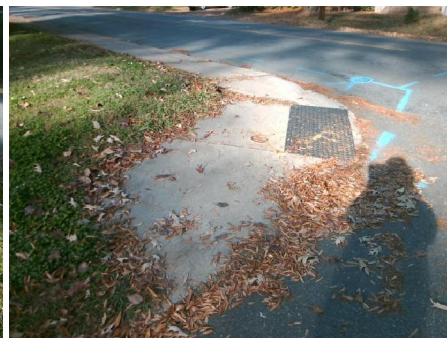
Compliance	Description	Data	Compliance	Description	Data
N/A	Ramp Length (in)	67.0	Yes	Ramp Slope (%)	6.2
Yes	Ramp Width (in)	48.0	No	Ramp XSlope (%)	14.0
N/A	Flare Type LT	N/A	N/A	Flare Type RT	N/A
N/A	Flare Slope LT (%)	N/A	N/A	Flare Slope RT (%)	N/A
N/A	Flare Traversable LT?	N/A	N/A	Flare Traversable RT?	N/A
N/A	Landing Length (in)	N/A	N/A	DWS Provided?	N/A
N/A	Landing Width (in)	N/A	N/A	DWS Contrast?	N/A
N/A	Landing Slope (%)	N/A	N/A	DWS Length (in)	N/A
N/A	Landing X Slope (%)	N/A	N/A	DWS Full Width?	N/A
N/A	Landing Curb? (Y/N)	N/A	N/A	DWS Offset (in)	N/A
N/A	Shared Landing?	N/A			
N/A	Gutter Ponding?	N/A	N/A	Gutter Slope (%)	N/A
N/A	Gutter Lip Ht (in)	N/A	N/A	Gutter X Slope (%)	N/A
N/A	Painted X Walk1?	No	N/A	Painted X Walk2?	N/A
	X Walk 1 Direction	To E		X Walk 2 Direction	N/A
N/A	X Walk 1 Width (in)	N/A	N/A	X Walk 2 Width (in)	N/A
	X Walk 1 Slope (%)	1.2		X Walk 2 Slope (%)	N/A
	X Walk 1 X Slope (%)	6.5		X Walk 2 X Slope (%)	N/A

Remove & Replace Entire Ramp.

R304.5.3
