Access Compliance Report Public Rights-of-Way (Curb Ramps)

Intersection ID: 27411 Main Street: BALLANTYNE_COMMONS_PY Cross Street: BALLANTYNE_CORPORATE_PL Location: NW

ADA ID: AA4AF6A6388D Ramp Type: Perp Initial Pass/Fail: Fail Overall Compliance: No Severity Score: 12.5

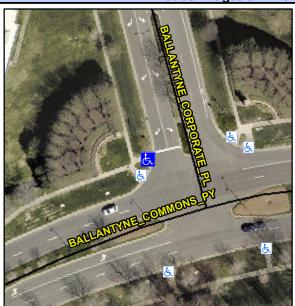
/Possible Solution Possible Solutions:			Field Measurements/Component Compliance					
		Comp	liance Description	Data	Compli	ance Description	Data	
Remove & Replace E	ntire Ramp.	N/A	Ramp Length (in)	135.0	Yes	Ramp Slope (%)	6.5	
·	-	Yes	Ramp Width (in)	48.0	No	Ramp XSlope (%)	6.2	
		N/A	Flare Type LT	N/A	N/A	Flare Type RT	N/A	
		N/A	Flare Slope LT (%)	N/A	N/A	Flare Slope RT (%)	N/A	
		N/A	Flare Traversable LT?	N/A	N/A	Flare Traversable RT?	N/A	
		N/A	Landing Length (in)	N/A	N/A	DWS Provided?	N/A	
Surveyor Notes:		N/A	Landing Width (in)	N/A	N/A	DWS Contrast?	N/A	
N/A		N/A	Landing Slope (%)	N/A	N/A	DWS Length (in)	N/A	
		N/A	Landing X Slope (%)	N/A	N/A	DWS Full Width?	N/A	
		N/A	Landing Curb? (Y/N)	N/A	N/A	DWS Offset (in)	N/A	
		N/A	Shared Landing?	N/A	i			
PROW/ADA:		N/A	Gutter Ponding?	N/A	N/A	Gutter Slope (%)	N/A	
Not Found, R304.5.3		N/A	Gutter Lip Ht (in)	N/A	N/A	Gutter X Slope (%)	N/A	
		N/A	Painted X Walk1?	No	N/A	Painted X Walk2?	N/A

X Walk 1 Direction	To E	i	X Walk 2 Direction	N/A	
		N/A	X Walk 1 Width (in)	N/A	N/A	X Walk 2 Width (in)	N/A	
			X Walk 1 Slope (%)	0.7	i	X Walk 2 Slope (%)	N/A	
			X Walk 1 X Slope (%)	3.8	i	X Walk 2 X Slope (%)	N/A	
		N/A	Ramp inside XWalk1?	N/A	N/A	Ramp inside XWalk2?	N/A	
			Road Slope (%)	N/A	N/A	Clear Space?	N/A	
			Road X Slope (%)	N/A	N/A	Clear Space to XWalk (in)	N/A	
		N/A	Any Obstructions?	N/A	N/A	Storm Grate/Utility Hazard?	N/A	
Total Cost:	\$ 1850	0.00	Obstruction Type		l	Storm Grate/Utility Type		
				N/A	1		N/A	
					Yes	Surface Condition? (G/P)	Good
