# Access Compliance Report

## Public Rights-of-Way

### (Curb Ramps)

Intersection ID: 29469	Main Street: BROOKCHASE LN	Cross Street: DOWNING ST	Location:	N
ADA ID: AA59357879C1	Ramp Type: PerpDiag	Initial Pass/Fail: Fail	Overall Compliance: No	Severity Score: 37.5
Codes/Mitigation Info/Possible Solution		Field Measurements/Component Compliance

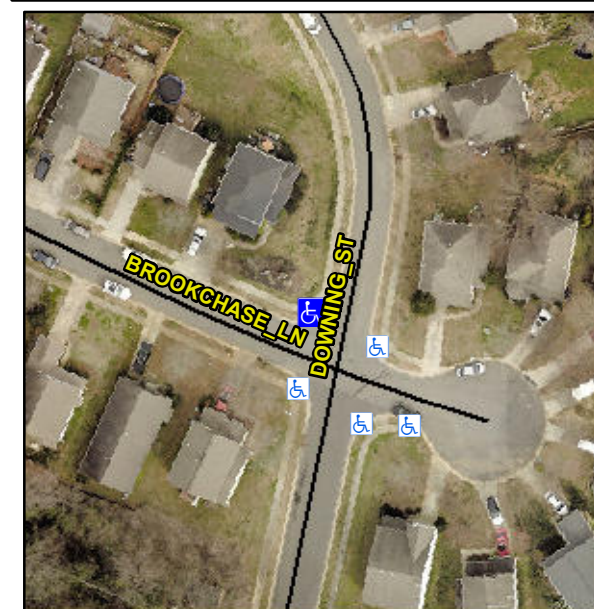
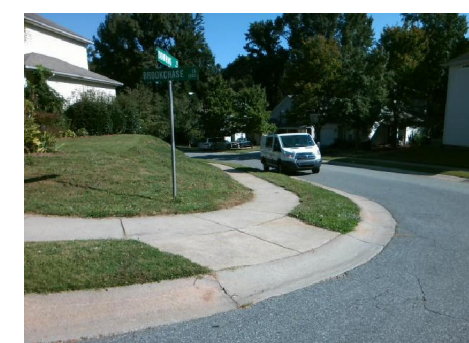
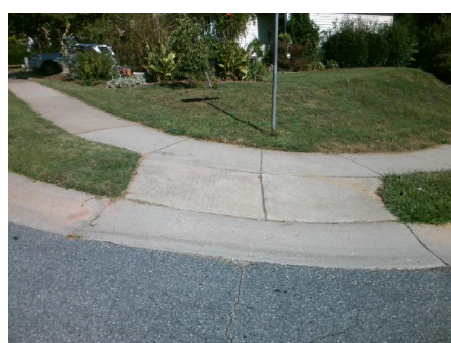
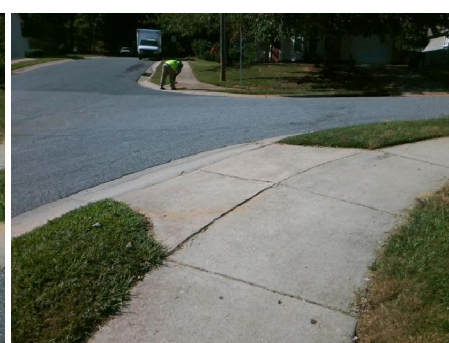
**Not Found, R304.2.2, R304.5.3**

Compliance	Description	Data	Compliance	Description	Data
N/A	Ramp Length (in)	46.5	No	Ramp Slope (%)	8.8
Yes	Ramp Width (in)	48.0	No	Ramp XSlope (%)	9.0
N/A	Flare Type LT	N/A	N/A	Flare Type RT	N/A
N/A	Flare Slope LT (%)	N/A	N/A	Flare Slope RT (%)	N/A
N/A	Flare Traversable LT?	N/A	N/A	Flare Traversable RT?	N/A
N/A	Landing Length (in)	N/A	N/A	DWS Provided?	N/A
N/A	Landing Width (in)	N/A	N/A	DWS Contrast?	N/A
N/A	Landing Slope (%)	N/A	N/A	DWS Length (in)	N/A
N/A	Landing X Slope (%)	N/A	N/A	DWS Full Width?	N/A
N/A	Landing Curb? (Y/N)	N/A	N/A	DWS Offset (in)	N/A
N/A	Shared Landing?	N/A			
N/A	Gutter Ponding?	N/A	N/A	Gutter Slope (%)	N/A
N/A	Gutter Lip Ht (in)	N/A	N/A	Gutter X Slope (%)	N/A
N/A	Painted X Walk1?	No	N/A	Painted X Walk2?	No
	X Walk 1 Direction	To SW		X Walk 2 Direction	To SE
N/A	X Walk 1 Width (in)	N/A	N/A	X Walk 2 Width (in)	N/A
	X Walk 1 Slope (%)	3.5		X Walk 2 Slope (%)	4.7
	X Walk 1 X Slope (%)	6.7		X Walk 2 X Slope (%)	4.1

N/A	Ramp inside XWalk1?	N/A	N/A	Ramp inside XWalk2?	N/A
	Road Slope (%)	9.2	N/A	Clear Space?	N/A
	Road X Slope (%)	1.2	N/A	Clear Space to XWalk (in)	N/A
N/A	Any Obstructions?	N/A	N/A	Storm Grate/Utility Hazard?	N/A
	Obstruction Type			Storm Grate/Utility Type	
		N/A			N/A
			Yes	Surface Condition? (G/P)	Good

**Remove & Replace Curb Ramp With Two New Directional Ramps or Equivalent.**
