# Access Compliance Report

## Public Rights-of-Way

### (Curb Ramps)

| Intersection ID: 29267 | Main Street: LAKOTA_CT | Cross Street: HORACE_MANN_RD | Location: E |

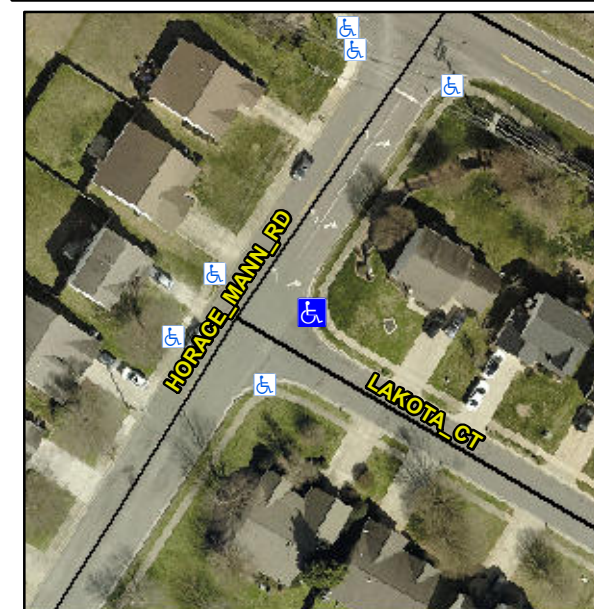
| ADA ID: AA5DF916746E | Ramp Type: PerpDiag | Initial Pass/Fail: Fail | Overall Compliance: No |
| Severity Score: 13.75 | | | |

**Not Found, R304.2.2, R304.5.3**

| Compliance | Description | Data | Compliance | Description | Data |
|---|---|---|---|---|---|
| N/A | Ramp Length (in) | 51.0 | No | Ramp Slope (%) | 9.0 |
| Yes | Ramp Width (in) | 48.0 | No | Ramp XSlope (%) | 2.5 |

**Remove & Replace Curb Ramp With Two New Directional Ramps or Equivalent.**

Total Cost: \$ 3200.00

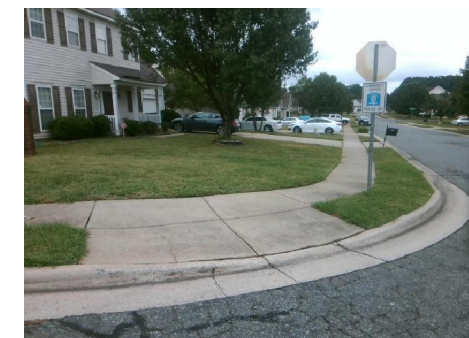
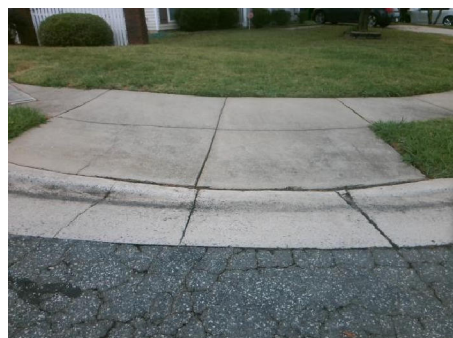
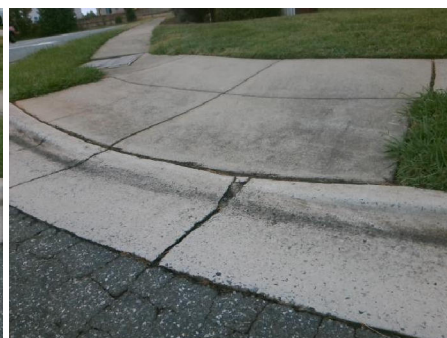
| Compliance | Description | Data | Compliance | Description | Data |
|---|---|---|---|---|---|
| | | Yes | | Surface Condition? (G/P) | Good |
