| Intersection ID: 27792 | Main Street: BLAKENEY_HEATH_RD | Cross Street: PARKS_FARM_LN | Location: | NW |
| ADA ID: AA68A4E92669 | Ramp Type: BlendTrans1 | Initial Pass/Fail: Fail | Overall Compliance: No | Severity Score: 8.75 |

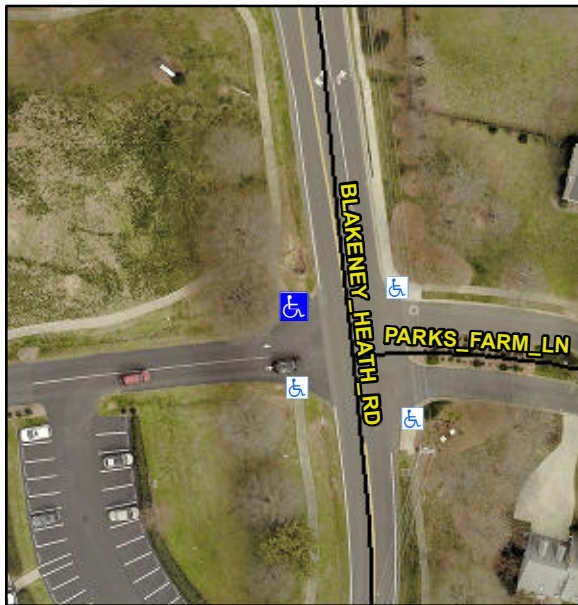
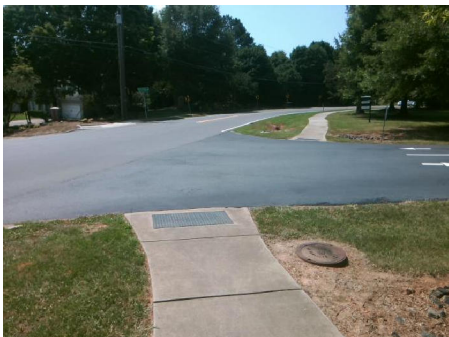
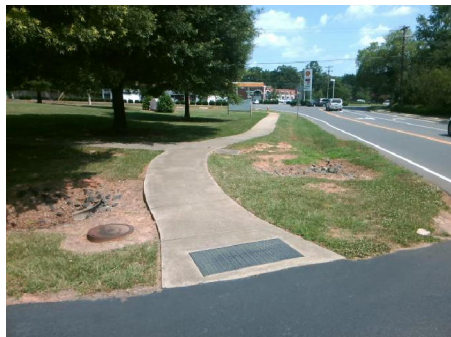
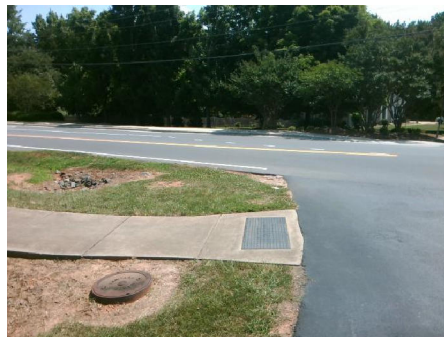
R304.5.1

| Compliance | Description | Data | Compliance | Description | Data |
|---|---|---|---|---|---|
| No | Ramp Width (in) | 47.0 | Yes | BlendTrans XSlope (%) | 0.7 |

Remove & Replace Curb Ramp With Two New Directional Ramps or Equivalent.

Total Cost: \$ 3200.00
