## **Access Compliance Report Public Rights-of-Way** (Curb Ramps)

Intersection ID: 15675 Main Street: EAST BV Cross Street: LOMBARDY CR Location: Ε **Overall Compliance: No Severity Score:** 25 **ADA ID: AA69691DB11C** Ramp Type: PerpDiag Initial Pass/Fail: Fail

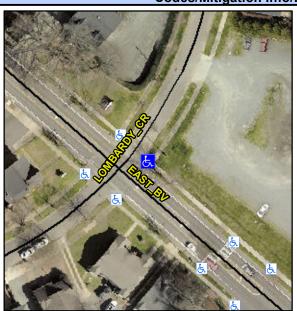
Compliance Description Data Compliance Description Data Yes N/A Ramp Length (in) 44.0 Ramp Slope (%) 6.0 No Ramp XSlope (%) Yes Ramp Width (in) 48.0 9.4 N/A N/A Flare Type LT N/A Flare Type RT N/A N/A N/A N/A Flare Slope RT (%) N/A Flare Slope LT (%) N/A Flare Traversable LT? N/A N/A Flare Traversable RT? N/A N/A N/A N/A **DWS Provided?** N/A Landing Length (in) N/A Landing Width (in) N/A N/A **DWS Contrast?** N/A N/A N/A Landing Slope (%) DWS Length (in) N/A Landing X Slope (%) N/A N/A DWS Full Width? N/A Landing Curb? (Y/N) N/A N/A DWS Offset (in) N/A N/A Shared Landing? **Gutter Ponding?** N/A N/A Gutter Slope (%) N/A Gutter Lip Ht (in) N/A N/A Gutter X Slope (%) N/A Painted X Walk1? No N/A Painted X Walk2? No X Walk 1 Direction To NW X Walk 2 Direction To SW N/A X Walk 1 Width (in) X Walk 2 Width (in) N/A X Walk 1 Slope (%) X Walk 2 Slope (%) 4.4 5.0 X Walk 2 X Slope (%) X Walk 1 X Slope (%) 3.5 5.0 N/A N/A Ramp inside XWalk2? N/A Ramp inside XWalk1? Road Slope (%) 3.5 N/A Clear Space? N/A N/A Road X Slope (%) 7.0 Clear Space to XWalk (in) N/A N/A N/A Any Obstructions? Storm Grate/Utility Hazard? N/A **Obstruction Type** Storm Grate/Utility Type N/A N/A

Possible Solutions: Remove & Replace Curb Ramp With Two New Directional Ramps or Equivalent. Surveyor Notes: N/A PROW/ADA: R304.5.3
