# Access Compliance Report

## Public Rights-of-Way

### (Curb Ramps)

Intersection ID: 17400		Main Street: BAINBRIDGE_RD		Cross Street: VISTA_DR		Location:		SE									
ADA ID: AA6E23BFFBD4		Ramp Type: Directional1		Initial Pass/Fail: Fail		Overall Compliance: No		Severity Score: 1.25									
Codes/Mitigation Info/Possible Solution				Field Measurements/Component Compliance

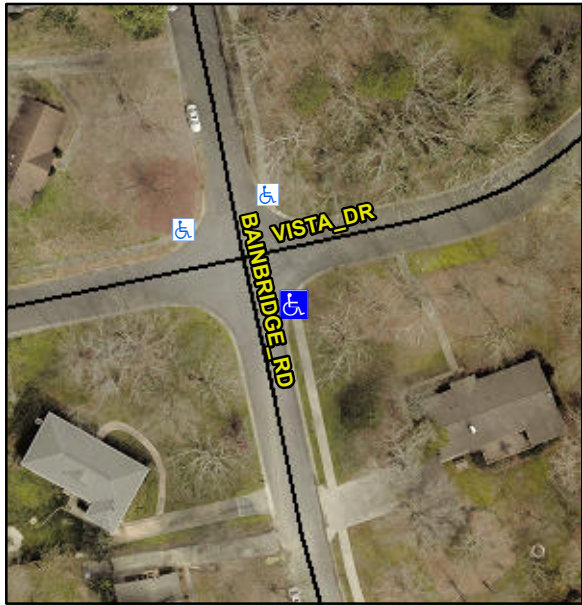
Possible Solutions:		Compliance		Description		Data							
				Remove & Replace Entire Ramp.		N/A		Ramp Length (in)		89.0		N/A					
Surveyor Notes:				N/A		Yes		Ramp Width (in)		60.0							
						Yes		Ramp Slope (%)		0.5							
PROW/ADA:				R304.5.3		No		Ramp XSlope (%)		2.2							
						N/A		Flare Type LT		N/A							
Street 1 Name				VISTA DR		N/A		Flare Slope LT (%)		N/A							
				StopSign		N/A		N/A		Flare Type RT		N/A					
Street 2 Name				N/A		N/A		Flare Traversable LT?		N/A							
				N/A		N/A		N/A		Flare Traversable RT?		N/A					
Stop Condition-Street 1						N/A		Landing Length (in)		0.0

N/A		N/A		Landing Width (in)		0.0					
Stop Condition-Street 2						N/A		N/A		DWS Provided?		N/A					
						N/A		N/A		N/A		DWS Contrast?		N/A			
Total Cost:				\$ 1600.00		N/A		N/A		DWS Length (in)		N/A					
						N/A		N/A		N/A		DWS Full Width?		N/A			
						N/A		N/A		N/A		DWS Offset LT (in)		N/A			
						N/A		N/A		N/A		N/A		DWS Offset RT (in)		N/A	
						N/A		N/A		N/A		N/A		Gutter Slope (%)		N/A	
						N/A		N/A		N/A		N/A		N/A		Gutter X Slope (%)	
						N/A		N/A		No		Road Slope (%)		4.8			
						N/A		N/A		To NW		Road X Slope (%)		1.1			
						N/A		N/A		N/A		Clear Space?		N/A			
						N/A		N/A		N/A		N/A		Clear Space to XWalk (in)		N/A	
						N/A		N/A		N/A		N/A		Storm Grate/Utility Hazard?		N/A	
						N/A		N/A		N/A		N/A		Storm Grate/Utility Type			
						N/A		N/A		N/A		N/A		Surface Condition? (G/P)		Good	
						N/A		N/A		N/A		N/A		Curb Slope (%)		16.5
