Access Compliance Report Public Rights-of-Way (Curb Ramps)

Intersection ID: 10022367 Main Street: CAMFIELD_ST Cross Street: N/A Location: NW

ADA ID: AA761864CDA7 Ramp Type: PerpDiag Initial Pass/Fail: Fail Overall Compliance: No Severity Score: 35

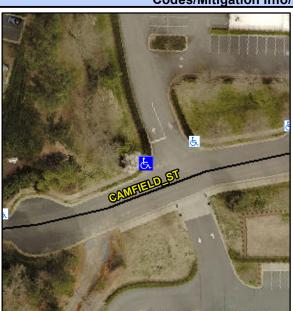
Compliance Description Data Compliance Description Yes N/A Ramp Length (in) 108.0 Ramp Slope (%) 31.5 Yes Ramp XSlope (%) No Ramp Width (in) N/A N/A Flare Type LT N/A Flare Type RT N/A Flare Slope LT (%) N/A N/A Flare Slope RT (%) N/A Flare Traversable LT? N/A N/A Flare Traversable RT? N/A Landing Length (in) N/A N/A **DWS Provided?** N/A Landing Width (in) N/A N/A **DWS Contrast?** N/A N/A N/A Landing Slope (%) DWS Length (in) N/A Landing X Slope (%) N/A N/A DWS Full Width? N/A Landing Curb? (Y/N) N/A N/A DWS Offset (in) N/A N/A Shared Landing? N/A Gutter Ponding? N/A N/A Gutter Slope (%) N/A Gutter Lip Ht (in) N/A N/A Gutter X Slope (%) N/A Painted X Walk1? No N/A Painted X Walk2? X Walk 1 Direction To S X Walk 2 Direction N/A N/A N/A X Walk 2 Width (in) X Walk 1 Width (in) X Walk 1 Slope (%) 1.6 X Walk 2 Slope (%) X Walk 1 X Slope (%) 1.1 X Walk 2 X Slope (%) N/A Ramp inside XWalk1? N/A N/A Ramp inside XWalk2?

Possible Solutions:

Remove & Replace Curb Ramp With
Two New Directional Ramps or
Equivalent.
