Access Compliance Report

Public Rights-of-Way

Intersection ID: 14299	Main Street: N_I-77_EXIT_8_RA	Cross Street: REMOUNT_RD	Location:	E
ADA ID: AA7862305838	Ramp Type: PerpDiag	Initial Pass/Fail: Fail	Overall Compliance: No	Severity Score: 50
Codes/Mitigation Info/Possible Solution		Field Measurements/Component Compliance

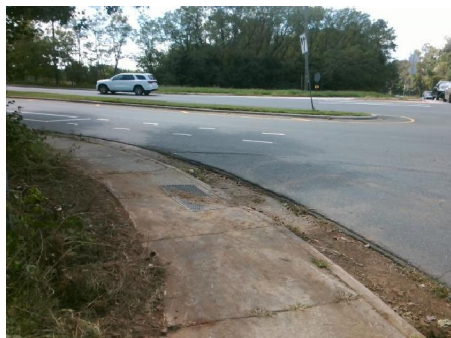
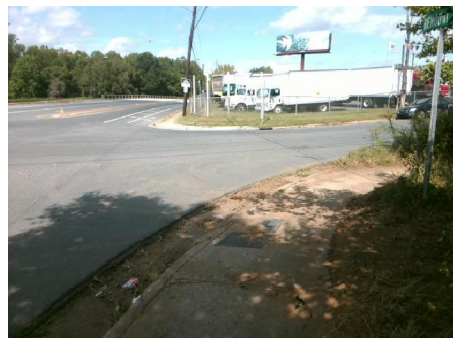
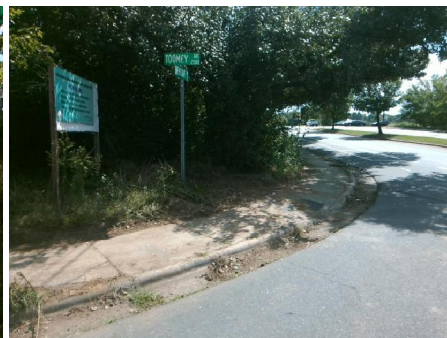
Compliance	Description	Data	Compliance	Description	Data
N/A	Ramp Length (in)	58.0	No	Ramp Slope (%)	14.6
Yes	Ramp Width (in)	48.0	No	Ramp XSlope (%)	11.1
N/A	Flare Type LT	N/A	N/A	Flare Type RT	N/A
N/A	Flare Slope LT (%)	N/A	N/A	Flare Slope RT (%)	N/A
N/A	Flare Traversable LT?	N/A	N/A	Flare Traversable RT?	N/A
N/A	Landing Length (in)	N/A	N/A	DWS Provided?	N/A
N/A	Landing Width (in)	N/A	N/A	DWS Contrast?	N/A
N/A	Landing Slope (%)	N/A	N/A	DWS Length (in)	N/A
N/A	Landing X Slope (%)	N/A	N/A	DWS Full Width?	N/A
N/A	Landing Curb? (Y/N)	N/A	N/A	DWS Offset (in)	N/A
N/A	Shared Landing?	N/A			
N/A	Gutter Ponding?	N/A	N/A	Gutter Slope (%)	N/A
N/A	Gutter Lip Ht (in)	N/A	N/A	Gutter X Slope (%)	N/A
N/A	Painted X Walk1?	No	N/A	Painted X Walk2?	No
	X Walk 1 Direction	To NW		X Walk 2 Direction	To SW
N/A	X Walk 1 Width (in)	N/A	N/A	X Walk 2 Width (in)	N/A
	X Walk 1 Slope (%)	0.9		X Walk 2 Slope (%)	4.4
	X Walk 1 X Slope (%)	5.8		X Walk 2 X Slope (%)	3.2

N/A	Ramp inside XWalk1?	N/A	N/A	Ramp inside XWalk2?	N/A
	Road Slope (%)	3.8	N/A	Clear Space?	N/A
	Road X Slope (%)	3.1	N/A	Clear Space to XWalk (in)	N/A
N/A	Any Obstructions?	N/A	N/A	Storm Grate/Utility Hazard?	N/A
	Obstruction Type			Storm Grate/Utility Type	
		N/A			N/A
		Yes		Surface Condition? (G/P)	Good

Possible Solutions:

Remove & Replace Curb Ramp With Two New Directional Ramps or Equivalent.

Not Found, R304.2.2, R304.5.3
