Access Compliance Report Public Rights-of-Way (Curb Ramps)

Intersection ID: 31913 Main Street: PARK_RD Cross Street: GINGERMILL_LN Location: NW **Overall Compliance: No Severity Score:** ADA ID: AA936908DF2A Ramp Type: Perp Initial Pass/Fail: Fail 1.25

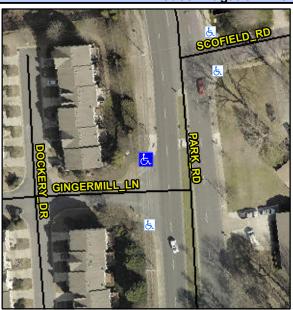
Field Measurements/Component Compliance									
	Compliance Description		Data	Comp	liance Description	Data			
	N/A	Ramp Length (in)	66.0	Yes	Ramp Slope (%)	5.7			
	Yes	Ramp Width (in)	61.0	No	Ramp XSlope (%)	2.2			
	N/A	Flare Type LT	N/A	N/A	Flare Type RT	N/A			
	N/A	Flare Slope LT (%)	N/A	N/A	Flare Slope RT (%)	N/A			
	N/A	Flare Traversable LT?	N/A	N/A	Flare Traversable RT?	N/A			
	N/A	Landing Length (in)	N/A	N/A	DWS Provided?	N/A			
	N/A	Landing Width (in)	N/A	N/A	DWS Contrast?	N/A			
	N/A	Landing Slope (%)	N/A	N/A	DWS Length (in)	N/A			
	N/A	Landing X Slope (%)	N/A	N/A	DWS Full Width?	N/A			
	N/A	Landing Curb? (Y/N)	N/A	N/A	DWS Offset (in)	N/A			
	N/A	Shared Landing?	N/A						
	N/A	Gutter Ponding?	N/A	N/A	Gutter Slope (%)	N/A			
	N/A	Gutter Lip Ht (in)	N/A	N/A	Gutter X Slope (%)	N/A			
	N/A	Painted X Walk1?	No	N/A	Painted X Walk2?	N/A			
		X Walk 1 Direction	To S		X Walk 2 Direction	N/A			
	N/A	X Walk 1 Width (in)	N/A	N/A	X Walk 2 Width (in)	N/A

X Walk 1 Slope (%)	2.9		X Walk 2 Slope (%)	N/A			
		X Walk 1 X Slope (%)	6.5		X Walk 2 X Slope (%)	N/A			
	N/A	Ramp inside XWalk1?	N/A	N/A	Ramp inside XWalk2?	N/A			
		Road Slope (%)	N/A	N/A	Clear Space?	N/A			
		Road X Slope (%)	N/A	N/A	Clear Space to XWalk (in)	N/A			
	N/A	Any Obstructions?	N/A	N/A	Storm Grate/Utility Hazard?	N/A			
		Obstruction Type			Storm Grate/Utility Type				
			N/A			N/A			
				Yes	Surface Condition? (G/P)	Good			
G

Possible Solutions:						
Remove & Replace Entire Ramp.						
O						
Surveyor Notes:						
N/A						
PROW/ADA:						
R304.5.3						
1.00 1.0.0
