# Access Compliance Report

## Public Rights-of-Way

### (Curb Ramps)

Intersection ID: 27889	Main Street: ELROSE_PL	Cross Street: GANDER_DR	Location: W
ADA ID: AAA8E602C5C7	Ramp Type: PerpDiag	Initial Pass/Fail: Fail	Overall Compliance: No
			Severity Score: 21.25

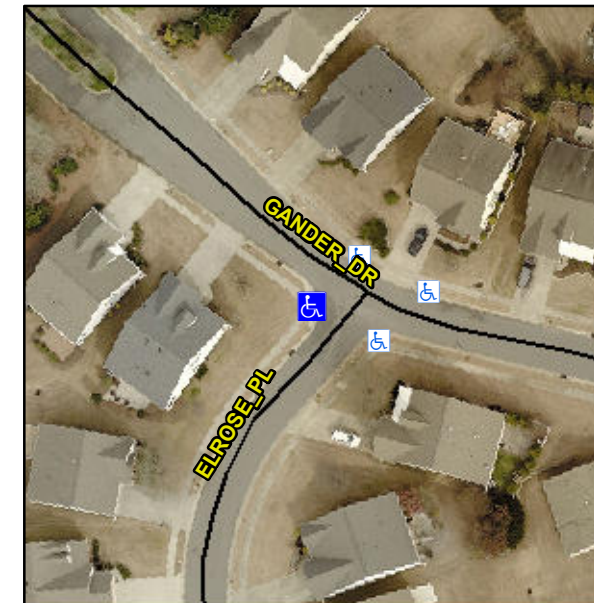
**Not Found, R304.5.1, R304.5.3**

Compliance	Description	Data	Compliance	Description	Data
N/A	Ramp Length (in)	96.0	Yes	Ramp Slope (%)	7.3
No	Ramp Width (in)	44.5	No	Ramp XSlope (%)	6.5
N/A	Flare Type LT	N/A	N/A	Flare Type RT	N/A
N/A	Flare Slope LT (%)	N/A	N/A	Flare Slope RT (%)	N/A
N/A	Flare Traversable LT?	N/A	N/A	Flare Traversable RT?	N/A
N/A	Landing Length (in)	N/A	N/A	DWS Provided?	N/A
N/A	Landing Width (in)	N/A	N/A	DWS Contrast?	N/A
N/A	Landing Slope (%)	N/A	N/A	DWS Length (in)	N/A
N/A	Landing X Slope (%)	N/A	N/A	DWS Full Width?	N/A
N/A	Landing Curb? (Y/N)	N/A	N/A	DWS Offset (in)	N/A
N/A	Shared Landing?	N/A			
N/A	Gutter Ponding?	N/A	N/A	Gutter Slope (%)	N/A
N/A	Gutter Lip Ht (in)	N/A	N/A	Gutter X Slope (%)	N/A
N/A	Painted X Walk1?	No	N/A	Painted X Walk2?	No
	X Walk 1 Direction	To SE		X Walk 2 Direction	To NE
N/A	X Walk 1 Width (in)	N/A	N/A	X Walk 2 Width (in)	N/A
	X Walk 1 Slope (%)	1.2		X Walk 2 Slope (%)	3.9
	X Walk 1 X Slope (%)	1.9		X Walk 2 X Slope (%)	3.7

N/A	Ramp inside XWalk1?	N/A	N/A	Ramp inside XWalk2?	N/A
	Road Slope (%)	0.9	N/A	Clear Space?	N/A
	Road X Slope (%)	2.1	N/A	Clear Space to XWalk (in)	N/A
N/A	Any Obstructions?	N/A	N/A	Storm Grate/Utility Hazard?	N/A
	Obstruction Type			Storm Grate/Utility Type	
		N/A			N/A
			Yes	Surface Condition? (G/P)	Good

**Remove & Replace Curb Ramp With Two New Directional Ramps or Equivalent.**
