Access Compliance Report

Public Rights-of-Way

(Curb Ramps)

Intersection ID: 11511	Main Street: E_18TH_ST	Cross Street: N_DAVIDSON_ST	Location: N
ADA ID: AABA60DCD6EC	Ramp Type: PerpDiag	Initial Pass/Fail: Fail	Overall Compliance: No
Severity Score: 13.75			
Codes/Mitigation Info/Possible Solution		Field Measurements/Component Compliance

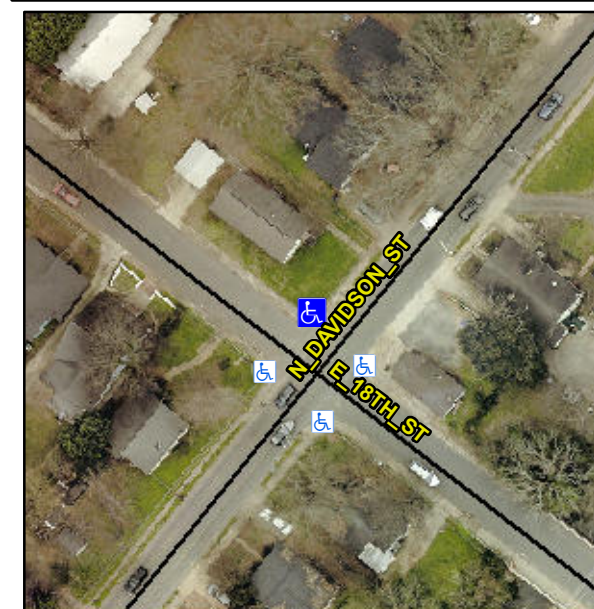
Not Found, R304.2.2, R304.5.3

Compliance	Description	Data	Compliance	Description	Data
N/A	Ramp Length (in)	57.0	No	Ramp Slope (%)	11.0
Yes	Ramp Width (in)	50.0	No	Ramp XSlope (%)	2.2
N/A	Flare Type LT	N/A	N/A	Flare Type RT	N/A
N/A	Flare Slope LT (%)	N/A	N/A	Flare Slope RT (%)	N/A
N/A	Flare Traversable LT?	N/A	N/A	Flare Traversable RT?	N/A
N/A	Landing Length (in)	N/A	N/A	DWS Provided?	N/A
N/A	Landing Width (in)	N/A	N/A	DWS Contrast?	N/A
N/A	Landing Slope (%)	N/A	N/A	DWS Length (in)	N/A
N/A	Landing X Slope (%)	N/A	N/A	DWS Full Width?	N/A
N/A	Landing Curb? (Y/N)	N/A	N/A	DWS Offset (in)	N/A
N/A	Shared Landing?	N/A			
N/A	Gutter Ponding?	N/A	N/A	Gutter Slope (%)	N/A
N/A	Gutter Lip Ht (in)	N/A	N/A	Gutter X Slope (%)	N/A
N/A	Painted X Walk1?	No	N/A	Painted X Walk2?	No
	X Walk 1 Direction	To SW		X Walk 2 Direction	To SE
N/A	X Walk 1 Width (in)	N/A	N/A	X Walk 2 Width (in)	N/A
	X Walk 1 Slope (%)	3.1		X Walk 2 Slope (%)	2.2
	X Walk 1 X Slope (%)	0.6		X Walk 2 X Slope (%)	3.4

N/A	Ramp inside XWalk1?	N/A	N/A	Ramp inside XWalk2?	N/A
	Road Slope (%)	0.5	N/A	Clear Space?	N/A
	Road X Slope (%)	3.5	N/A	Clear Space to XWalk (in)	N/A
N/A	Any Obstructions?	N/A	N/A	Storm Grate/Utility Hazard?	N/A
	Obstruction Type			Storm Grate/Utility Type	
		N/A			N/A
		Yes		Surface Condition? (G/P)	Good

Possible Solutions:

Remove & Replace Curb Ramp With Two New Directional Ramps or Equivalent.
