Access Compliance Report Public Rights-of-Way (Curb Ramps)

Intersection ID: 8323Main Street: JENNINGS_STCross Street: CATHERINE_SIMMONS_AVLocation:NEADA ID: AAC1D393022ERamp Type: PerpInitial Pass/Fail: PassOverall Compliance: NoSeverity Score:10

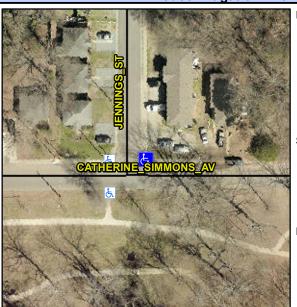
Field Measurements/Component Compliance								
Compliance Description Data			Comp	liance Description	Data			
N/A	Ramp Length (in)	41.0	Yes	Ramp Slope (%)	5.4			
Yes	Ramp Width (in)	48.0	Yes	Ramp XSlope (%)	0.4			
N/A	Flare Type LT	Sloped	N/A	Flare Type RT	N/A			
N/A	Flare Slope LT (%)	2.0	Yes	Flare Slope RT (%)	1.5			
N/A	Flare Traversable LT?	Yes	N/A	Flare Traversable RT?	Yes			
No	Landing Length (in)	N/A	Yes	DWS Provided?	Yes			
No	Landing Width (in)	N/A	Yes	DWS Contrast?	Yes			
No	Landing Slope (%)	N/A	Yes	DWS Length (in)	24.5			
No	Landing X Slope (%)	N/A	Yes	DWS Full Width?	Yes			
N/A	Landing Curb? (Y/N)	No	Yes	DWS Offset (in)	0.0			
N/A	Shared Landing?	No						
Yes	Gutter Ponding?	No	Yes	Gutter Slope (%)	4.3			
Yes	Gutter Lip Ht (in)	0.0	Yes	Gutter X Slope (%)	0.7			
N/A	Painted X Walk1?	No	N/A	Painted X Walk2?	N/A			
	X Walk 1 Direction	To W		X Walk 2 Direction	N/A			
N/A	X Walk 1 Width (in)	N/A	N/A	X Walk 2 Width (in)	N/A

X Walk 1 Slope (%)	3.3		X Walk 2 Slope (%)	N/A			
	X Walk 1 X Slope (%)	1.0		X Walk 2 X Slope (%)	N/A			
N/A	Ramp inside XWalk1?	N/A	N/A	Ramp inside XWalk2?	N/A			
	Road Slope (%)	N/A	N/A	Clear Space?	Yes			
	Road X Slope (%)	N/A	N/A	Clear Space to XWalk (in)	N/A			
Yes	Any Obstructions?	No	Yes	Storm Grate/Utility Hazard?	No			
	Obstruction Type			Storm Grate/Utility Type				
		N/A			N/A			
			Yes	Surface Condition? (G/P)	Good

<u> </u>	1 CCCIBIC CCIGNON	
Sec. of	Possible Solutions:	Co
	Remove & Replace Entire Ramp.	N/A
1		Ye
		N/A
SALES OF		N/A
No.		N/A
A 47 %		No
	Surveyor Notes:	No
	N/A	No
1		No
7		N/A
		N/A
	PROW/ADA:	Ye
	Not Found, R304.2.1, R304.2.2-Perp,	Ye
1	R304.3.2-Para, R304.5.3	N/A
No.		
		N/A
		N/A
