## **Access Compliance Report Public Rights-of-Way** (Curb Ramps)

Intersection ID: 18716 Main Street: COLONY\_RD Cross Street: RUNNYMEDE\_LN Location: NE **Overall Compliance: No** ADA ID: AAD5DB5767C2 Ramp Type: Perp Initial Pass/Fail: Fail **Severity Score:** 55

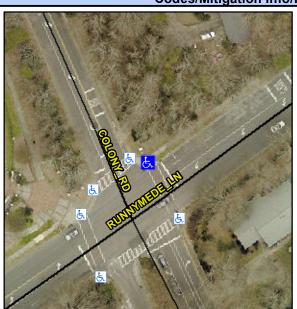
Comp	liance Description	Data	Comp	liance	Description	Data
N/A	Ramp Length (in)	99.0	No	Ramp	Slope (%)	8.7
No	Ramp Width (in)	34.5	No	Ramp	XSlope (%)	10.1
N/A	Flare Type LT	N/A	N/A	Flare	Type RT	N/A
N/A	Flare Slope LT (%)	N/A	N/A	Flare	Slope RT (%)	N/A
N/A	Flare Traversable LT?	N/A	N/A	Flare	Traversable RT?	N/A
N/A	Landing Length (in)	N/A	N/A	DWS	Provided?	N/A
N/A	Landing Width (in)	N/A	N/A	DWS	Contrast?	N/A
N/A	Landing Slope (%)	N/A	N/A	DWS Length (in)		N/A
N/A	Landing X Slope (%)	N/A	N/A	DWS Full Width?		N/A
N/A	Landing Curb? (Y/N)	N/A	N/A	DWS	Offset (in)	N/A
N/A	Shared Landing?	N/A				
N/A	Gutter Ponding?	N/A	N/A	Gutte	Slope (%)	N/A
N/A	Gutter Lip Ht (in)	N/A	N/A	Gutte	X Slope (%)	N/A
N/A	Painted X Walk1?	Yes	N/A	Painte	ed X Walk2?	N/A
	X Walk 1 Direction	To SE		X Wal	k 2 Direction	N/A
N/A	X Walk 1 Width (in)	118.0	N/A	X Wal	k 2 Width (in)	N/A
	X Walk 1 Slope (%)	1.3		X Wal	k 2 Slope (%)	N/A
	X Walk 1 X Slope (%)	6.5		X Wal	k 2 X Slope (%)	N/A

N/A	Ramp inside XWalk1?	Yes	N/A	Ramp	inside XWalk2?	N/A
	Road Slope (%)	N/A	N/A	Clear	Space?	N/A
	Road X Slope (%)	N/A	N/A	Clear	Space to XWalk (in)	N/A
N/A	Any Obstructions?	N/A	N/A	Storm	Grate/Utility Hazard?	N/A
	Obstruction Type			Storm	Grate/Utility Type	
		N/A				N/A
			Yes	Surfac	ce Condition? (G/P)	Good

Possible Solutions:	
Remove & Replace Entire Ramp.	ı
	ı
	ı
	ı
	l
Company Natao	
Surveyor Notes:	
N/A	
	'
PROW/ADA:	İ
Not Found, R304.5.1, R304.2.2,	ı
R304.5.3	ı
	l
