# Access Compliance Report

## Public Rights-of-Way

### (Curb Ramps)

| Intersection ID: 50271 | Main Street: CLANTON_RD | Cross Street: SOUTH_BV | Location: SE |

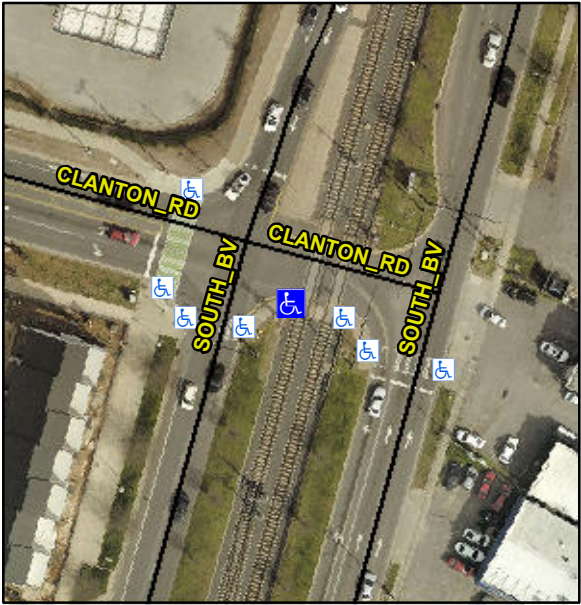
| ADA ID: AADA0A352402 | Ramp Type: Perp | Initial Pass/Fail: Fail | Overall Compliance: No |
| | | | Severity Score: 26.25 |

| Codes/Mitigation Info/Possible Solution | | | Field Measurements/Component Compliance | | |
|---|---|--|---|---|---|
| <p>Surveyor Notes:</p> <p>N/A</p> <p>PROW/ADA:</p> <p>R304.2.2, R304.5.3</p> | | | N/A | Flare Type RT | N/A |

| Codes/Mitigation Info/Possible Solution | | | Field Measurements/Component Compliance | | |
|---|---|--|---|---|---|
| | Remove & Replace Entire Ramp. | | N/A | Ramp Length (in) | 78.0 |
