# Access Compliance Report

## Public Rights-of-Way

Intersection ID: 9711	Main Street: N_DAVIDSON_ST	Cross Street: PATTERSON_ST	Location: SE
ADA ID: AAFA1E7F814C	Ramp Type: Perp	Initial Pass/Fail: Fail	Overall Compliance: No
Severity Score: 8.75			
Codes/Mitigation Info/Possible Solution		Field Measurements/Component Compliance

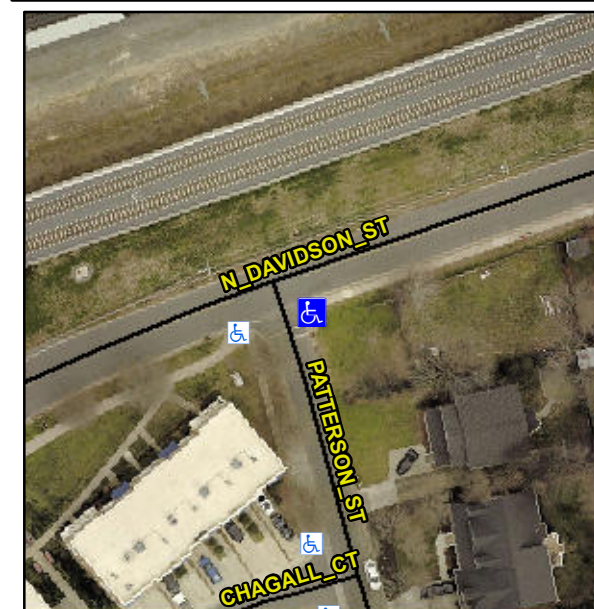
**Not Found, R304.5.1**

Compliance	Description	Data	Compliance	Description	Data
N/A	Ramp Length (in)	50.0	Yes	Ramp Slope (%)	8.0
No	Ramp Width (in)	43.0	Yes	Ramp XSlope (%)	0.2
N/A	Flare Type LT	N/A	N/A	Flare Type RT	N/A
N/A	Flare Slope LT (%)	N/A	N/A	Flare Slope RT (%)	N/A
N/A	Flare Traversable LT?	N/A	N/A	Flare Traversable RT?	N/A
N/A	Landing Length (in)	N/A	N/A	DWS Provided?	N/A
N/A	Landing Width (in)	N/A	N/A	DWS Contrast?	N/A
N/A	Landing Slope (%)	N/A	N/A	DWS Length (in)	N/A
N/A	Landing X Slope (%)	N/A	N/A	DWS Full Width?	N/A
N/A	Landing Curb? (Y/N)	N/A	N/A	DWS Offset (in)	N/A
N/A	Shared Landing?	N/A			
N/A	Gutter Ponding?	N/A	N/A	Gutter Slope (%)	N/A
N/A	Gutter Lip Ht (in)	N/A	N/A	Gutter X Slope (%)	N/A
N/A	Painted X Walk1?	No	N/A	Painted X Walk2?	N/A
	X Walk 1 Direction	To W		X Walk 2 Direction	N/A
N/A	X Walk 1 Width (in)	N/A	N/A	X Walk 2 Width (in)	N/A
	X Walk 1 Slope (%)	1.6		X Walk 2 Slope (%)	N/A
	X Walk 1 X Slope (%)	0.9		X Walk 2 X Slope (%)	N/A

**Remove & Replace Entire Ramp.**

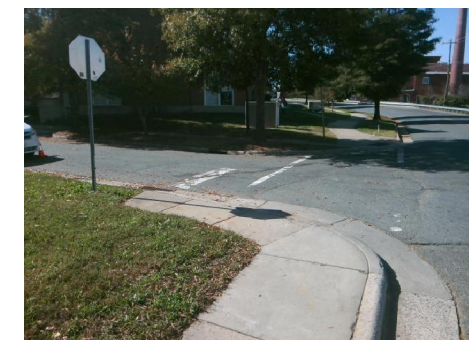
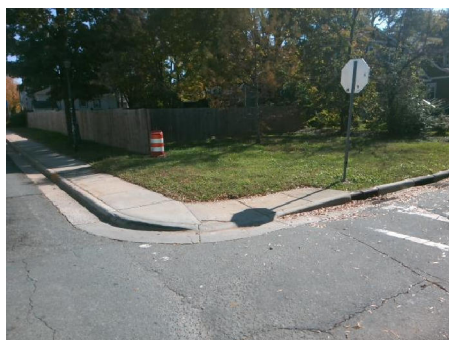
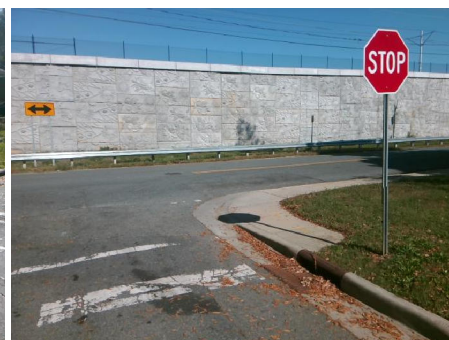
N/A	Ramp inside XWalk1?	N/A	N/A	Ramp inside XWalk2?	N/A
	Road Slope (%)	N/A	N/A	Clear Space?	N/A
	Road X Slope (%)	N/A	N/A	Clear Space to XWalk (in)	N/A
N/A	Any Obstructions?	N/A	N/A	Storm Grate/Utility Hazard?	N/A
	Obstruction Type			Storm Grate/Utility Type	
		N/A			N/A
		Yes		Surface Condition? (G/P)	Good
