Access Compliance Report Public Rights-of-Way (Curb Ramps)

Intersection ID: N/AMain Street:E_PROVIDENCE_RDCross Street:N/ALocation:NWADA ID: AAFEF8FA3D20Ramp Type:PerpDiagInitial Pass/Fail:FailOverall Compliance:NoSeverity Score:25

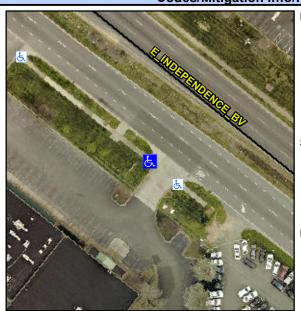
Not Found, R304.2.2, R304.5.3

Compliance Description		Data	ata Compliance Description		Data
1	N/A	Ramp Length (in)	48.0	No	Ramp Slope (%)	8.9
١	⁄es	Ramp Width (in)	48.0	No	Ramp XSlope (%)	6.1
N	N/A	Flare Type LT	N/A	N/A	Flare Type RT	N/A
1	N/A	Flare Slope LT (%)	N/A	N/A	Flare Slope RT (%)	N/A
1	N/A	Flare Traversable LT?	N/A	N/A	Flare Traversable RT?	N/A
1	N/A	Landing Length (in)	N/A	N/A	DWS Provided?	N/A
1	N/A	Landing Width (in)	N/A	N/A	DWS Contrast?	N/A
1	N/A	Landing Slope (%)	N/A	N/A	DWS Length (in)	N/A
١	N/A	Landing X Slope (%)	N/A	N/A	DWS Full Width?	N/A
1	N/A	Landing Curb? (Y/N)	N/A	N/A	DWS Offset (in)	N/A
1	N/A	Shared Landing?	N/A			
1	N/A	Gutter Ponding?	N/A	N/A	Gutter Slope (%)	N/A
N	N/A	Gutter Lip Ht (in)	N/A	N/A	Gutter X Slope (%)	N/A
1	N/A	Painted X Walk1?	No	N/A	Painted X Walk2?	No
		X Walk 1 Direction	To SE		X Walk 2 Direction	To NE
1	N/A	X Walk 1 Width (in)	N/A	N/A	X Walk 2 Width (in)	N/A
		X Walk 1 Slope (%)	0.6		X Walk 2 Slope (%)	5.5

X Walk 1 X Slope (%)	0.2		X Walk 2 X Slope (%)	0.4
1	N/A	Ramp inside XWalk1?	N/A	N/A	Ramp inside XWalk2?	N/A
		Road Slope (%)	2.1	N/A	Clear Space?	N/A
		Road X Slope (%)	5.2	N/A	Clear Space to XWalk (in)	N/A
ı	N/A	Any Obstructions?	N/A	N/A	Storm Grate/Utility Hazard?	N/A
		Obstruction Type			Storm Grate/Utility Type	
			N/A			N/A

ENTRANCE None E PROVIDENCE RD None Possible Solutions:

Remove & Replace Curb Ramp With Two New Directional Ramps or Equivalent.
