# Access Compliance Report

## Public Rights-of-Way

### (Curb Ramps)

Intersection ID: 53713	Main Street: N_TRYON_ST	Cross Street: PERIWINKLE_HILL_AV	Location: E
ADA ID: AB0273D29DA9	Ramp Type: Perp	Initial Pass/Fail: Fail	Overall Compliance: No
Severity Score: 10			
Codes/Mitigation Info/Possible Solution		Field Measurements/Component Compliance

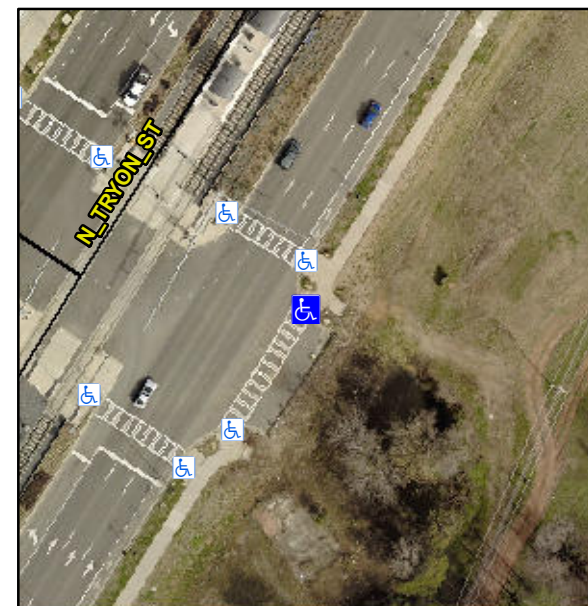
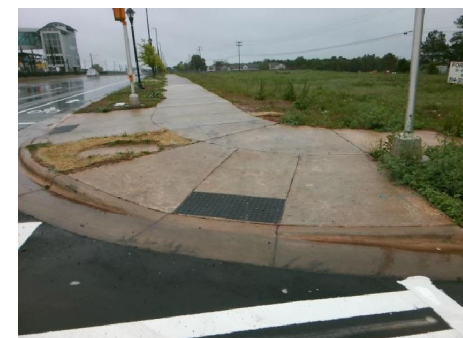
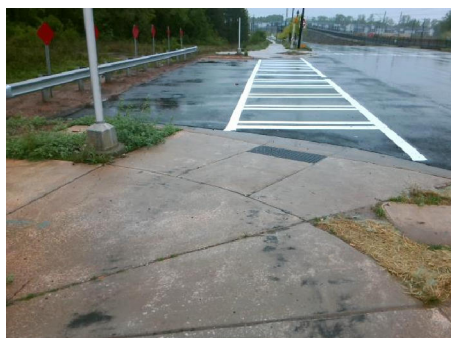
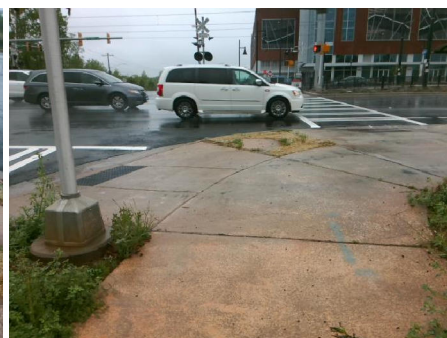
Compliance	Description	Data	Compliance	Description	Data
N/A	Ramp Length (in)	97.0	Yes	Ramp Slope (%)	6.4
No	Ramp Width (in)	43.0	Yes	Ramp XSlope (%)	3.2
N/A	Flare Type LT	N/A	N/A	Flare Type RT	N/A
N/A	Flare Slope LT (%)	N/A	N/A	Flare Slope RT (%)	N/A
N/A	Flare Traversable LT?	N/A	N/A	Flare Traversable RT?	N/A
N/A	Landing Length (in)	N/A	N/A	DWS Provided?	N/A
N/A	Landing Width (in)	N/A	N/A	DWS Contrast?	N/A
N/A	Landing Slope (%)	N/A	N/A	DWS Length (in)	N/A
N/A	Landing X Slope (%)	N/A	N/A	DWS Full Width?	N/A
N/A	Landing Curb? (Y/N)	N/A	N/A	DWS Offset (in)	N/A
N/A	Shared Landing?	N/A			
N/A	Gutter Ponding?	N/A	N/A	Gutter Slope (%)	N/A
N/A	Gutter Lip Ht (in)	N/A	N/A	Gutter X Slope (%)	N/A
N/A	Painted X Walk1?	Yes	N/A	Painted X Walk2?	N/A
	X Walk 1 Direction	To SW		X Walk 2 Direction	N/A
N/A	X Walk 1 Width (in)	113.0	N/A	X Walk 2 Width (in)	N/A
	X Walk 1 Slope (%)	1.4		X Walk 2 Slope (%)	N/A
	X Walk 1 X Slope (%)	4.8		X Walk 2 X Slope (%)	N/A

N/A	Ramp inside XWalk1?	Yes	N/A	Ramp inside XWalk2?	N/A
	Road Slope (%)	N/A	N/A	Clear Space?	N/A
	Road X Slope (%)	N/A	N/A	Clear Space to XWalk (in)	N/A
N/A	Any Obstructions?	N/A	N/A	Storm Grate/Utility Hazard?	N/A
	Obstruction Type			Storm Grate/Utility Type	
		N/A			N/A
		Yes		Surface Condition? (G/P)	Good

Possible Solutions:

**Remove & Replace Entire Ramp.**

**R304.5.1**
