# Access Compliance Report

## Public Rights-of-Way

### (Curb Ramps)

Intersection ID: 46026	Main Street: BITTINGER_CT	Cross Street: PAULINE_LN	Location: NE
ADA ID: AB0F51B0D8E7	Ramp Type: PerpDiag	Initial Pass/Fail: Fail	Overall Compliance: No
Severity Score: 22.5			
Codes/Mitigation Info/Possible Solution		Field Measurements/Component Compliance

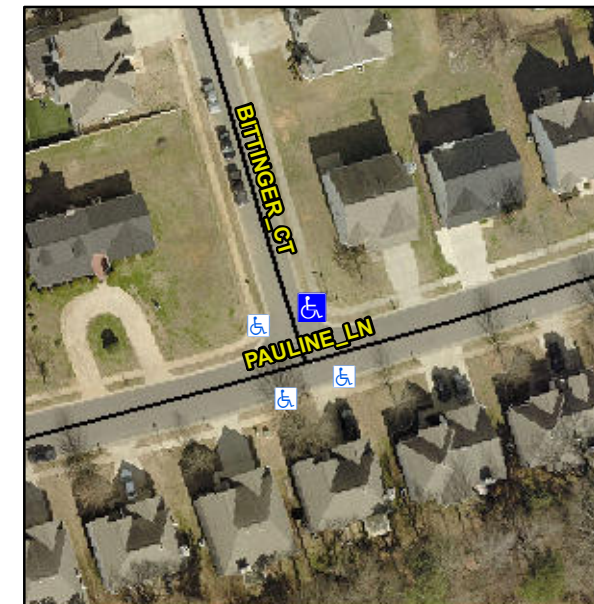
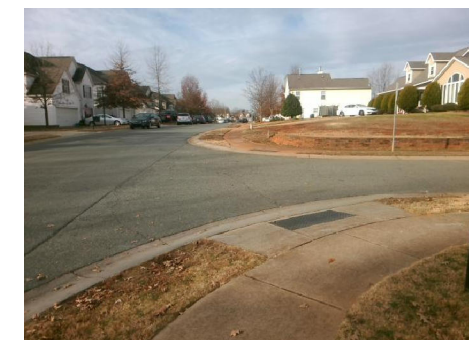
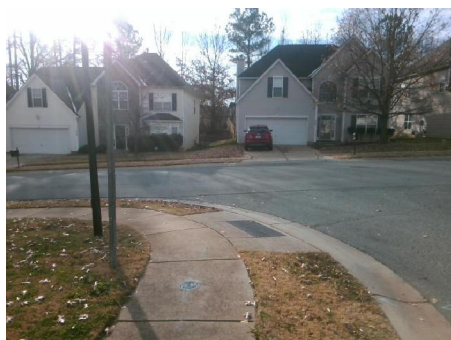
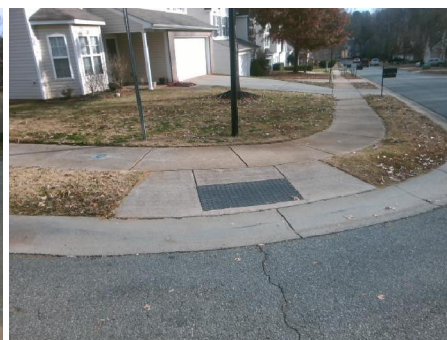
**Not Found, R304.5.1, R304.2.2, R304.5.3**

Compliance	Description	Data	Compliance	Description	Data
N/A	Ramp Length (in)	48.0	No	Ramp Slope (%)	8.6
No	Ramp Width (in)	47.5	No	Ramp XSlope (%)	3.8
N/A	Flare Type LT	N/A	N/A	Flare Type RT	N/A
N/A	Flare Slope LT (%)	N/A	N/A	Flare Slope RT (%)	N/A
N/A	Flare Traversable LT?	N/A	N/A	Flare Traversable RT?	N/A
N/A	Landing Length (in)	N/A	N/A	DWS Provided?	N/A
N/A	Landing Width (in)	N/A	N/A	DWS Contrast?	N/A
N/A	Landing Slope (%)	N/A	N/A	DWS Length (in)	N/A
N/A	Landing X Slope (%)	N/A	N/A	DWS Full Width?	N/A
N/A	Landing Curb? (Y/N)	N/A	N/A	DWS Offset (in)	N/A
N/A	Shared Landing?	N/A			
N/A	Gutter Ponding?	N/A	N/A	Gutter Slope (%)	N/A
N/A	Gutter Lip Ht (in)	N/A	N/A	Gutter X Slope (%)	N/A
N/A	Painted X Walk1?	No	N/A	Painted X Walk2?	No
	X Walk 1 Direction	To W		X Walk 2 Direction	To S
N/A	X Walk 1 Width (in)	N/A	N/A	X Walk 2 Width (in)	N/A
	X Walk 1 Slope (%)	5.4		X Walk 2 Slope (%)	1.7
	X Walk 1 X Slope (%)	1.6		X Walk 2 X Slope (%)	6.6

N/A	Ramp inside XWalk1?	N/A	N/A	Ramp inside XWalk2?	N/A
	Road Slope (%)	3.4	N/A	Clear Space?	N/A
	Road X Slope (%)	5.8	N/A	Clear Space to XWalk (in)	N/A
N/A	Any Obstructions?	N/A	N/A	Storm Grate/Utility Hazard?	N/A
	Obstruction Type			Storm Grate/Utility Type	
		N/A			N/A
			Yes	Surface Condition? (G/P)	Good

**Remove & Replace Curb Ramp With Two New Directional Ramps or Equivalent.**

Total Cost: \$ 3200.00
