Access Compliance Report

Public Rights-of-Way

(Curb Ramps)

| Intersection ID: 17570 | Main Street: RANDOLPH_RD | Cross Street: WOODLARK_LN | Location: W |

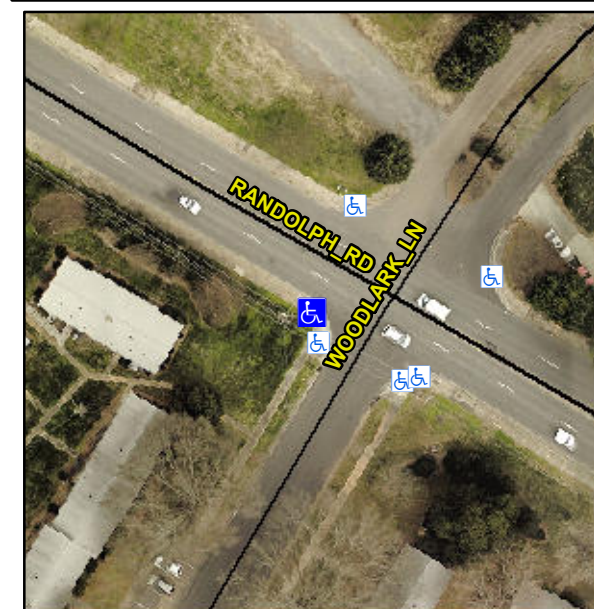
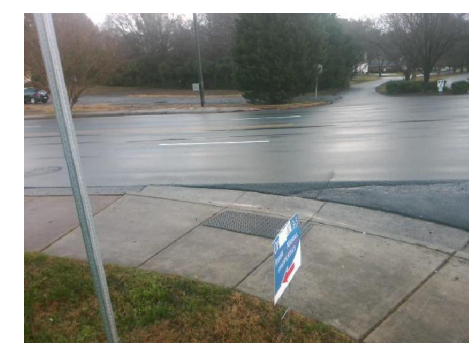
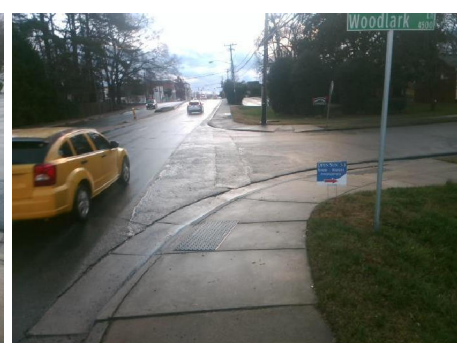
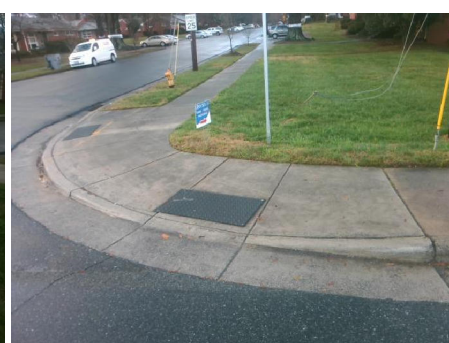
| ADA ID: AB19AE495C4B | Ramp Type: Perp | Initial Pass/Fail: Fail | Overall Compliance: No |

Not Found, R304.5.1

| Compliance | Description | Data | Compliance | Description | Data |
|---|---|---|---|---|---|
| N/A | Ramp Length (in) | 72.0 | Yes | Ramp Slope (%) | 5.2 |
| No | Ramp Width (in) | 40.0 | Yes | Ramp XSlope (%) | 1.7 |

Remove & Replace Entire Ramp.
