# Access Compliance Report

## Public Rights-of-Way

### (Curb Ramps)

| Intersection ID: N/A | Main Street: OLD_CONCORD_RD | Cross Street: ORCHID_BRIDGE_RD | Location: SW |

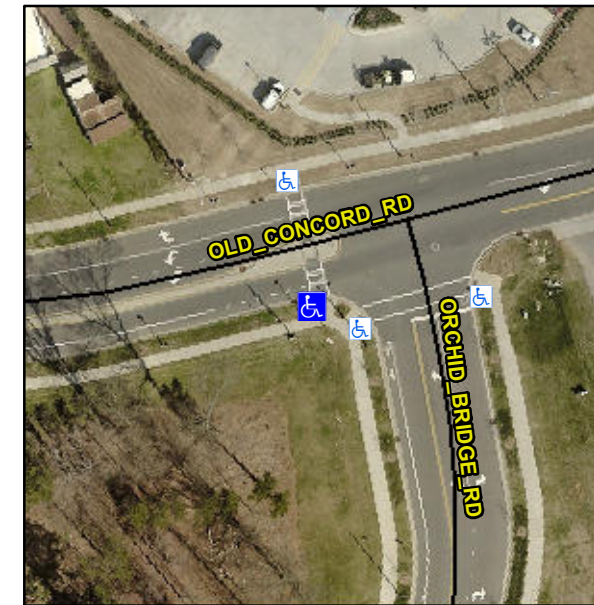
| ADA ID: AB27E1B1717D | Ramp Type: Perp | Initial Pass/Fail: Fail | Overall Compliance: No |

**R304.5.1, R304.5.3**

| Compliance | Description | Data | Compliance | Description | Data |
|---|---|---|---|---|---|
| N/A | Ramp Length (in) | 98.0 | Yes | Ramp Slope (%) | 8.2 |
| No | Ramp Width (in) | 46.0 | No | Ramp XSlope (%) | 3.3 |

**Remove & Replace Entire Ramp.**

Total Cost: \$ 1850.00
