Access Compliance Report

Public Rights-of-Way

(Curb Ramps)

Intersection ID: 29171	Main Street: CHIEFTAIN_DR	Cross Street: COUGAR_HILL_CT	Location: E
ADA ID: AB3DF92D01BD	Ramp Type: Perp	Initial Pass/Fail: Fail	Overall Compliance: No
Severity Score: 21.25			
Codes/Mitigation Info/Possible Solution		Field Measurements/Component Compliance

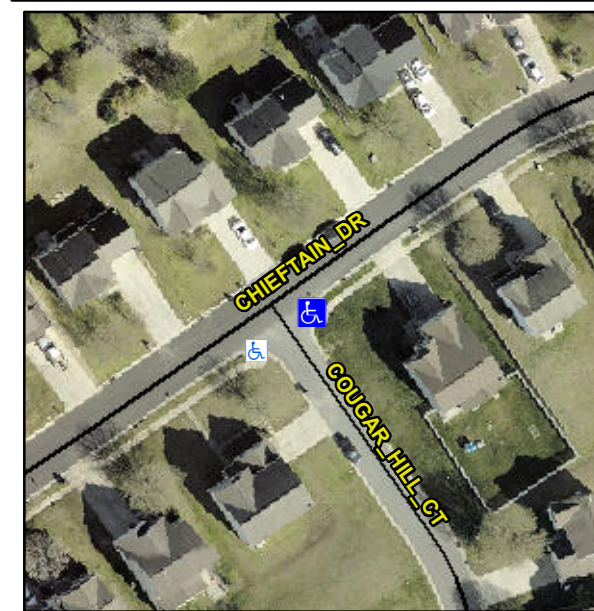
R304.5.1, R304.5.3

Compliance	Description	Data	Compliance	Description	Data
N/A	Ramp Length (in)	45.0	Yes	Ramp Slope (%)	6.9
No	Ramp Width (in)	47.2	No	Ramp XSlope (%)	6.9
N/A	Flare Type LT	N/A	N/A	Flare Type RT	N/A
N/A	Flare Slope LT (%)	N/A	N/A	Flare Slope RT (%)	N/A
N/A	Flare Traversable LT?	N/A	N/A	Flare Traversable RT?	N/A
N/A	Landing Length (in)	N/A	N/A	DWS Provided?	N/A
N/A	Landing Width (in)	N/A	N/A	DWS Contrast?	N/A
N/A	Landing Slope (%)	N/A	N/A	DWS Length (in)	N/A
N/A	Landing X Slope (%)	N/A	N/A	DWS Full Width?	N/A
N/A	Landing Curb? (Y/N)	N/A	N/A	DWS Offset (in)	N/A
N/A	Shared Landing?	N/A			
N/A	Gutter Ponding?	N/A	N/A	Gutter Slope (%)	N/A
N/A	Gutter Lip Ht (in)	N/A	N/A	Gutter X Slope (%)	N/A
N/A	Painted X Walk1?	No	N/A	Painted X Walk2?	N/A
	X Walk 1 Direction	To SW		X Walk 2 Direction	N/A
N/A	X Walk 1 Width (in)	N/A	N/A	X Walk 2 Width (in)	N/A
	X Walk 1 Slope (%)	3.8		X Walk 2 Slope (%)	N/A
	X Walk 1 X Slope (%)	2.3		X Walk 2 X Slope (%)	N/A

N/A	Ramp inside XWalk1?	N/A	N/A	Ramp inside XWalk2?	N/A
	Road Slope (%)	N/A	N/A	Clear Space?	N/A
	Road X Slope (%)	N/A	N/A	Clear Space to XWalk (in)	N/A
N/A	Any Obstructions?	N/A	N/A	Storm Grate/Utility Hazard?	N/A
	Obstruction Type			Storm Grate/Utility Type	
		N/A			N/A
		Yes		Surface Condition? (G/P)	Good

Possible Solutions:

Remove & Replace Entire Ramp.
