Access Compliance Report

Public Rights-of-Way

(Curb Ramps)

| Intersection ID: 13035 | Main Street: W_CARSON_BV | Cross Street: WINNIFRED_ST | Location: S |

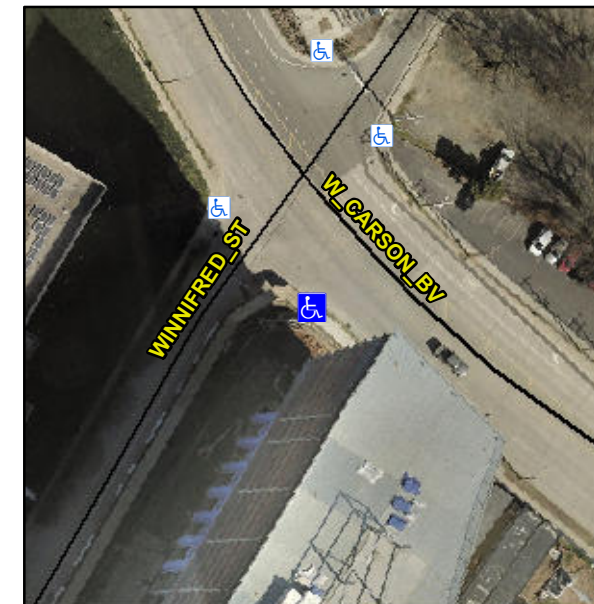
| ADA ID: AB424D071C84 | Ramp Type: Perp | Initial Pass/Fail: Fail | Overall Compliance: No |

Not Found, R304.2.2

| Compliance | Description | Data | Compliance | Description | Data |
|---|---|---|---|---|---|
| N/A | Ramp Length (in) | 63.0 | No | Ramp Slope (%) | 14.3 |

Remove & Replace Entire Ramp.
