Access Compliance Report Public Rights-of-Way (Curb Ramps)

Intersection ID: 9851 Main Street: BREWTON_DR Cross Street: TINNIN_AV Location: SW **ADA ID: AB48B6EE380B** Ramp Type: Perp Initial Pass/Fail: Fail **Overall Compliance: No Severity Score:** 22.5

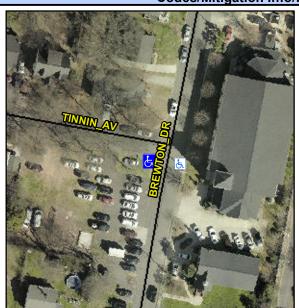
/Possible Solution		Field Measurements/Component Compliance					
Possible Solutions:		Compl	iance Description	Data	Compliance	Description	Data
Remove & Replace Entire R	amp.	N/A	Ramp Length (in)	67.0	No Ran	np Slope (%)	9.6

-	No	Ramp Width (in)	38.0	Yes Ran	np XSlope (%)	3.3
		N/A	Flare Type LT	N/A	N/A Flar	e Type RT	N/A
		N/A	Flare Slope LT (%)	N/A	N/A Flar	e Slope RT (%)	N/A
		N/A	Flare Traversable LT?	N/A	N/A Flar	e Traversable RT?	N/A
		N/A	Landing Length (in)	N/A	N/A DW	S Provided?	N/A
Surveyor Notes:		N/A	Landing Width (in)	N/A	N/A DW	S Contrast?	N/A
N/A		N/A	Landing Slope (%)	N/A	N/A DW	S Length (in)	N/A
		N/A	Landing X Slope (%)	N/A	N/A DW	S Full Width?	N/A
		N/A	Landing Curb? (Y/N)	N/A	N/A DW	S Offset (in)	N/A
		N/A	Shared Landing?	N/A			
PROW/ADA:		N/A	Gutter Ponding?	Yes	N/A Gut	ter Slope (%)	N/A
R304.5.1, R304.2.2		N/A	Gutter Lip Ht (in)	N/A	N/A Gut	ter X Slope (%)	N/A
		N/A	Painted X Walk1?	No	N/A Pair	nted X Walk2?	N/A
			X Walk 1 Direction	To E	ΧW	alk 2 Direction	N/A
		N/A	X Walk 1 Width (in)	N/A	N/A X W	alk 2 Width (in)	N/A
			X Walk 1 Slope (%)	4.1	ΧW	alk 2 Slope (%)	N/A
			X Walk 1 X Slope (%)	4.5	ΧW	alk 2 X Slope (%)	N/A
