Access Compliance Report Public Rights-of-Way (Curb Ramps)

Intersection ID: N/A Main Street: PROVIDENCE RD **Cross Street: N/A** Location: NW ADA ID: AB4B2599753E Ramp Type: PerpDiag Initial Pass/Fail: Fail **Overall Compliance: No Severity Score:** 35

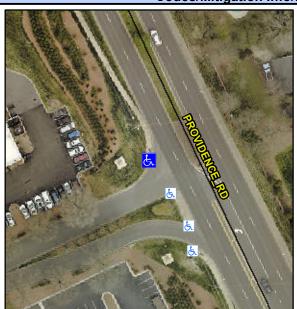
Comp	liance Description	Data	Comp	liance	Description	Data
N/A	Ramp Length (in)	62.0	No	Ramp	Slope (%)	13.8
No	Ramp Width (in)	46.5	No	Ramp	XSlope (%)	2.6
N/A	Flare Type LT	N/A	N/A	Flare	Type RT	N/A
N/A	Flare Slope LT (%)	N/A	N/A	Flare	Slope RT (%)	N/A
N/A	Flare Traversable LT?	N/A	N/A	Flare	Traversable RT?	N/A
N/A	Landing Length (in)	N/A	N/A	DWS	Provided?	N/A
N/A	Landing Width (in)	N/A	N/A	DWS	Contrast?	N/A
N/A	Landing Slope (%)	N/A	N/A	DWS	Length (in)	N/A
N/A	Landing X Slope (%)	N/A	N/A	DWS	Full Width?	N/A
N/A	Landing Curb? (Y/N)	N/A	N/A	DWS	Offset (in)	N/A
N/A	Shared Landing?	N/A				
N/A	Gutter Ponding?	N/A	N/A	Gutte	r Slope (%)	N/A
N/A	Gutter Lip Ht (in)	N/A	N/A	Gutte	r X Slope (%)	N/A
N/A	Painted X Walk1?	No	N/A	Paint	ed X Walk2?	No
	X Walk 1 Direction	To SE		X Wa	lk 2 Direction	To NE
N/A	X Walk 1 Width (in)	N/A	N/A	X Wa	lk 2 Width (in)	N/A
	X Walk 1 Slope (%)	1.4		X Wa	lk 2 Slope (%)	5.8
	X Walk 1 X Slope (%)	5.2		X Wa	lk 2 X Slope (%)	0.5

N/A	Ramp inside XWalk1?	N/A	N/A	Ramp	inside XWalk2?	N/A
	Road Slope (%)	2.0	N/A	Clear	Space?	N/A
	Road X Slope (%)	4.6	N/A	Clear	Space to XWalk (in)	N/A
N/A	Any Obstructions?	N/A	N/A	Storm	Grate/Utility Hazard?	N/A
	Obstruction Type		l	Storm	Grate/Utility Type	
		NI/A	I			N/A

Street 1 Name Stop Condition-Street 2 Street 2 Name Stop Condition-Street 1 Remove & Replace Curb Ramp With Two New Directional Ramps or Equivalent.

R304.5.1, R304.2.2, R304.5.3
