Access Compliance Report

Public Rights-of-Way

(Curb Ramps)

Intersection ID: 2703	Main Street: CROWNVISTA_DR	Cross Street: STARGAZE_LN	Location:	E
ADA ID: AB515FCA145E	Ramp Type: PerpDiag	Initial Pass/Fail: Fail	Overall Compliance: No	Severity Score: 21.25

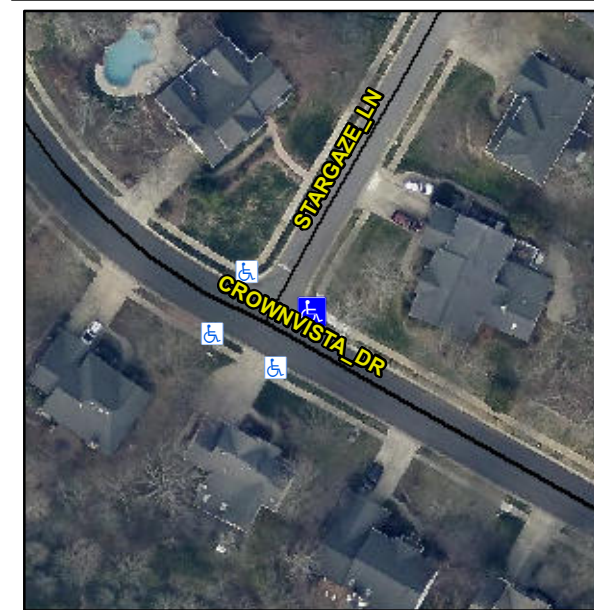
Not Found, R304.5.1, R304.2.2

Compliance	Description	Data	Compliance	Description	Data
N/A	Ramp Length (in)	46.0	No	Ramp Slope (%)	8.5
No	Ramp Width (in)	40.0	Yes	Ramp XSlope (%)	0.1
N/A	Flare Type LT	N/A	N/A	Flare Type RT	N/A
N/A	Flare Slope LT (%)	N/A	N/A	Flare Slope RT (%)	N/A
N/A	Flare Traversable LT?	N/A	N/A	Flare Traversable RT?	N/A
N/A	Landing Length (in)	N/A	N/A	DWS Provided?	N/A
N/A	Landing Width (in)	N/A	N/A	DWS Contrast?	N/A
N/A	Landing Slope (%)	N/A	N/A	DWS Length (in)	N/A
N/A	Landing X Slope (%)	N/A	N/A	DWS Full Width?	N/A
N/A	Landing Curb? (Y/N)	N/A	N/A	DWS Offset (in)	N/A
N/A	Shared Landing?	N/A			
N/A	Gutter Ponding?	N/A	N/A	Gutter Slope (%)	N/A
N/A	Gutter Lip Ht (in)	N/A	N/A	Gutter X Slope (%)	N/A
N/A	Painted X Walk1?	No	N/A	Painted X Walk2?	No
	X Walk 1 Direction	To NW		X Walk 2 Direction	To SW
N/A	X Walk 1 Width (in)	N/A	N/A	X Walk 2 Width (in)	N/A
	X Walk 1 Slope (%)	3.2		X Walk 2 Slope (%)	4.5
	X Walk 1 X Slope (%)	3.0		X Walk 2 X Slope (%)	1.5

N/A	Ramp inside XWalk1?	N/A	N/A	Ramp inside XWalk2?	N/A
	Road Slope (%)	0.5	N/A	Clear Space?	N/A
	Road X Slope (%)	4.3	N/A	Clear Space to XWalk (in)	N/A
N/A	Any Obstructions?	N/A	N/A	Storm Grate/Utility Hazard?	N/A
	Obstruction Type			Storm Grate/Utility Type	
		N/A			N/A
			Yes	Surface Condition? (G/P)	Good

Remove & Replace Curb Ramp With Two New Directional Ramps or Equivalent.
