## Access Compliance Report Public Rights-of-Way (Curb Ramps)

Intersection ID: N/A	Main Street: ARDREY_KELL_DR			Street:	N/A	Location:	NE		
ADA ID: AB5945A87739	Ramp Ty	ype: PerpDiag	Initial P	itial Pass/Fail: Fail Overall Compliance: No				Severity Score:	35
Codes/Mitigation Info/Possible Solution				Field Measurements/Component Compliance

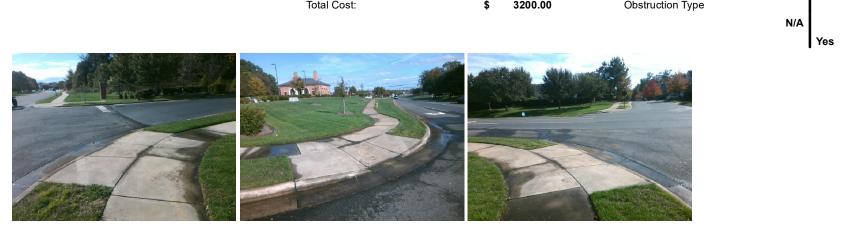
-	Possible Solutions:		Compliance Description		Data Compliance Description			Data
Charles of		Remove & Replace Curb Ramp W	/ith	N/A	Ramp Length (in)	82.0	No	Ramp Slope (%)	14.4
		Two New Directional Ramps or		No	Ramp Width (in)	44.0	No	Ramp XSlope (%)	2.6
		Equivalent.		N/A	Flare Type LT	N/A	N/A	Flare Type RT	N/A
				N/A	Flare Slope LT (%)	N/A	N/A	Flare Slope RT (%)	N/A
				N/A	Flare Traversable LT?	N/A	N/A	Flare Traversable RT?	N/A
	and the second			N/A	Landing Length (in)	N/A	N/A	DWS Provided?	N/A
	ED	Surveyor Notes:		N/A	Landing Width (in)	N/A	N/A	DWS Contrast?	N/A
727		N/A		N/A	Landing Slope (%)	N/A	N/A	DWS Length (in)	N/A
				N/A	Landing X Slope (%)	N/A	N/A	DWS Full Width?	N/A
the second secon	Line and the second sec			N/A	Landing Curb? (Y/N)	N/A	N/A	DWS Offset (in)	N/A
CARDon -	6.			N/A	Shared Landing?	N/A			
		PROW/ADA:		N/A	Gutter Ponding?	N/A	N/A	Gutter Slope (%)	N/A
		Not Found, R304.5.1, R304.2.2,		N/A	Gutter Lip Ht (in)	N/A	N/A	Gutter X Slope (%)	N/A

the second	L SA	R304.5.3		N/A	Painted X Walk1?	No	N/A	Painted X Walk2?	No
e de la companya de l	A AV att				X Walk 1 Direction	To SW		X Walk 2 Direction	To SE
				N/A	X Walk 1 Width (in)	N/A	N/A	X Walk 2 Width (in)	N/A
Street 1 Name	ENTRANCE				X Walk 1 Slope (%)	1.6		X Walk 2 Slope (%)	0.9
Stop Condition-Street 2	StopSign				X Walk 1 X Slope (%)	0.1		X Walk 2 X Slope (%)	0.4
Street 2 Name	ARDREY KELL RD			N/A	Ramp inside XWalk1?	N/A	N/A	Ramp inside XWalk2?	N/A
Stop Condition-Street 1	None				Road Slope (%)	1.1	N/A	Clear Space?	N/A
					Road X Slope (%)	0.3	N/A	Clear Space to XWalk (in)	N/A
				N/A	Any Obstructions?	N/A	N/A	Storm Grate/Utility Hazard?	N/A
		Total Cost: \$ 32	200.00		Obstruction Type			Storm Grate/Utility Type	
l						N/A			N/A
