Access Compliance Report

Public Rights-of-Way

(Curb Ramps)

| Intersection ID: 10025975 | Main Street: ELM_LN | Cross Street: N/A | Location: SW |

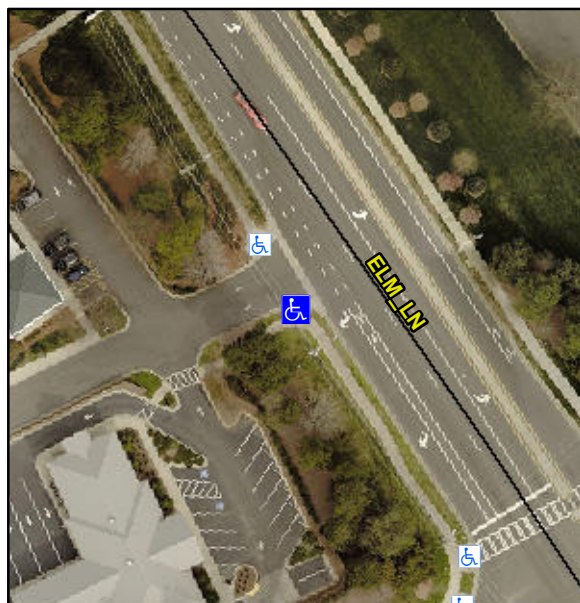
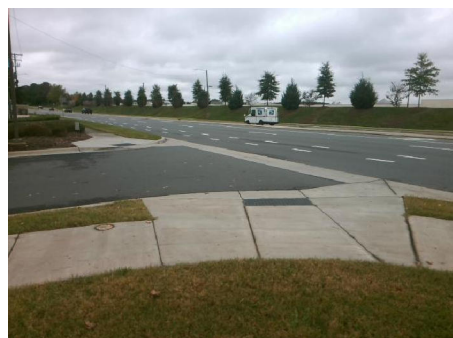
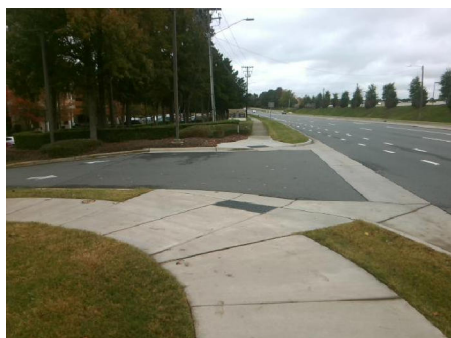
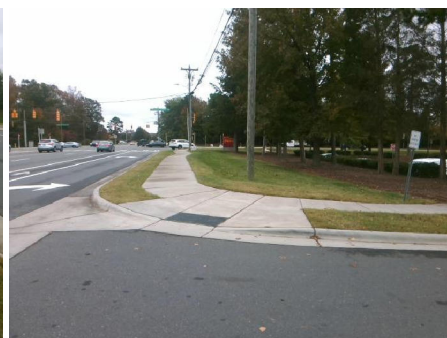
| ADA ID: AB676BF3A445 | Ramp Type: Perp | Initial Pass/Fail: Fail | Overall Compliance: No |

R304.5.1, R304.5.3

| Compliance | Description | Data | Compliance | Description | Data |
|---|---|---|---|---|---|
| N/A | Ramp Length (in) | 125.0 | Yes | Ramp Slope (%) | 6.7 |
| No | Ramp Width (in) | 45.0 | No | Ramp XSlope (%) | 5.9 |

Remove & Replace Entire Ramp.
