Access Compliance Report

Public Rights-of-Way (Curb Ramps)

Intersection ID: N/A	Main Street: CRESSWIND BV	Cross Street: SHOFF CIR	Location: N
ADA ID: AB6F91EF91A7	Ramp Type: Perp	Initial Pass/Fail: Fail	Overall Compliance: No
		Severity Score: 12.5

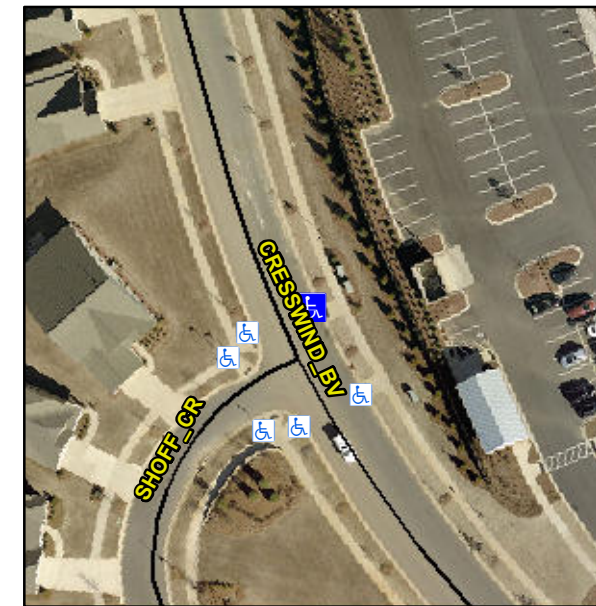
Not Found, R304.5.3

Compliance	Description	Data	Compliance	Description	Data
N/A	Ramp Length (in)	97.0	Yes	Ramp Slope (%)	5.2
Yes	Ramp Width (in)	60.0	No	Ramp XSlope (%)	5.7
N/A	Flare Type LT	N/A	N/A	Flare Type RT	N/A
N/A	Flare Slope LT (%)	N/A	N/A	Flare Slope RT (%)	N/A
N/A	Flare Traversable LT?	No	N/A	Flare Traversable RT?	No
N/A	Landing Length (in)	N/A	N/A	DWS Provided?	N/A
N/A	Landing Width (in)	N/A	N/A	DWS Contrast?	N/A
N/A	Landing Slope (%)	N/A	N/A	DWS Length (in)	N/A
N/A	Landing X Slope (%)	N/A	N/A	DWS Full Width?	N/A
N/A	Landing Curb? (Y/N)	N/A	N/A	DWS Offset (in)	N/A
N/A	Shared Landing?	N/A			
N/A	Gutter Ponding?	N/A	N/A	Gutter Slope (%)	N/A
N/A	Gutter Lip Ht (in)	3.0	N/A	Gutter X Slope (%)	N/A
N/A	Painted X Walk1?	No	N/A	Painted X Walk2?	N/A
	X Walk 1 Direction	To S		X Walk 2 Direction	N/A
N/A	X Walk 1 Width (in)	N/A	N/A	X Walk 2 Width (in)	N/A
	X Walk 1 Slope (%)	3.4		X Walk 2 Slope (%)	N/A
	X Walk 1 X Slope (%)	4.5		X Walk 2 X Slope (%)	N/A

N/A	Ramp inside XWalk1?	N/A	N/A	Ramp inside XWalk2?	N/A
	Road Slope (%)	N/A	N/A	Clear Space?	N/A
	Road X Slope (%)	N/A	N/A	Clear Space to XWalk (in)	N/A
N/A	Any Obstructions?	N/A	N/A	Storm Grate/Utility Hazard?	N/A
	Obstruction Type			Storm Grate/Utility Type	
		N/A			N/A
		Yes		Surface Condition? (G/P)	Good

Remove & Replace Entire Ramp.
