Access Compliance Report

Public Rights-of-Way

(Curb Ramps)

| Intersection ID: 42468 | Main Street: MARVIN_RD | Cross Street: KINGSLEY_VIEW_DR | Location: NW |

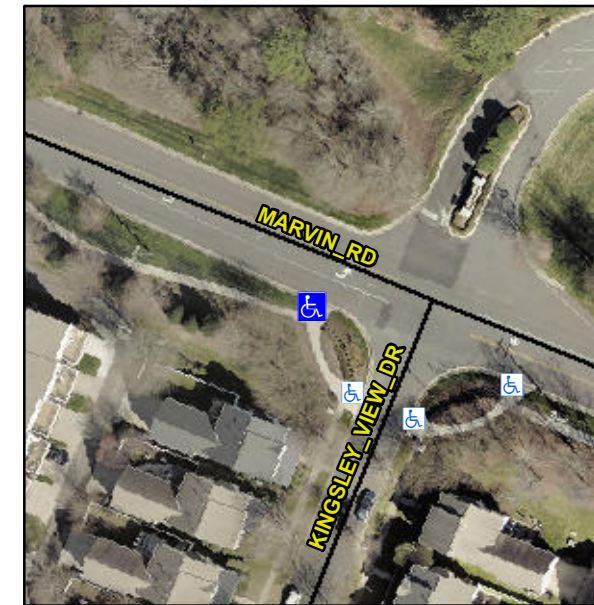
| ADA ID: AB728A5A9520 | Ramp Type: Perp | Initial Pass/Fail: Fail | Overall Compliance: No |

Not Found, R304.2.2

| Compliance | Description | Data | Compliance | Description | Data |
|---|---|---|---|---|---|
| N/A | Ramp Length (in) | 73.0 | No | Ramp Slope (%) | 11.3 |

Possible Solutions:

Remove & Replace Entire Ramp.

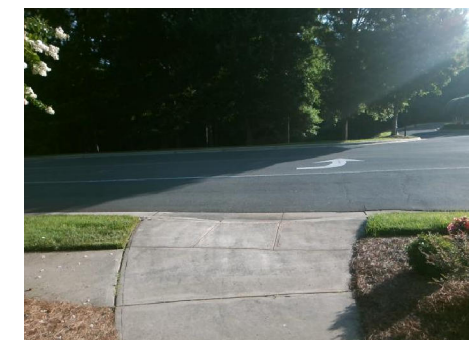
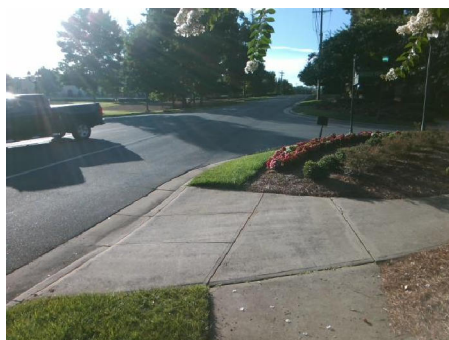
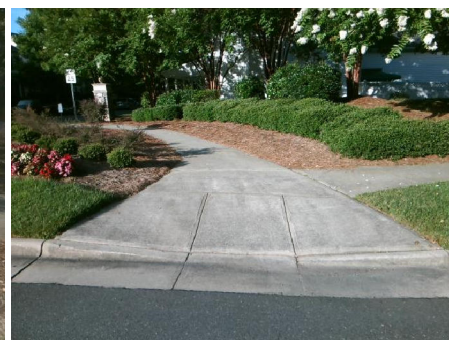
| Compliance | Description | Data | Compliance | Description | Data |
|---|---|---|---|---|---|
| Yes | Ramp Width (in) | 48.0 | Yes | Ramp XSlope (%) | 1.3 |
| | | | Yes | Surface Condition? (G/P) | Good |
