# Access Compliance Report

## Public Rights-of-Way

Intersection ID: 3572	Main Street: BEECH_CREST_PL	Cross Street: HARRIS_GLEN_DR	Location: NW
ADA ID: AB7F88AD834D	Ramp Type: Perp	Initial Pass/Fail: Fail	Overall Compliance: No
			Severity Score: 21.25

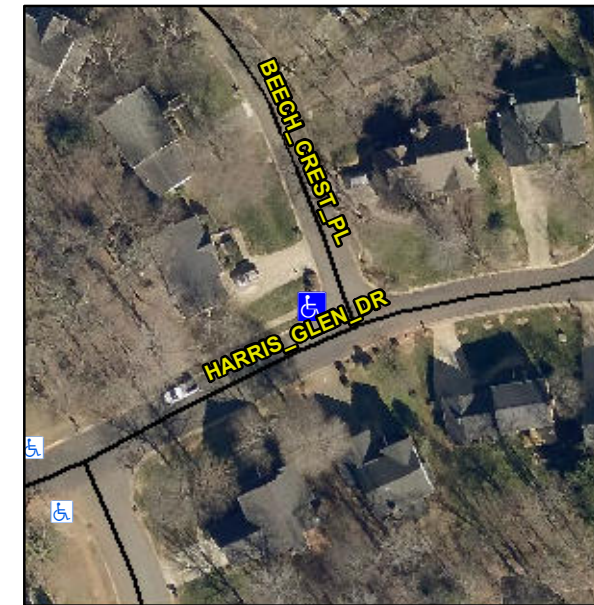
Compliance	Description	Data	Compliance	Description	Data
N/A	Ramp Length (in)	68.0	No	Ramp Slope (%)	11.2
No	Ramp Width (in)	47.5	Yes	Ramp XSlope (%)	1.9
N/A	Flare Type LT	N/A	N/A	Flare Type RT	N/A
N/A	Flare Slope LT (%)	N/A	N/A	Flare Slope RT (%)	N/A
N/A	Flare Traversable LT?	N/A	N/A	Flare Traversable RT?	N/A
N/A	Landing Length (in)	N/A	N/A	DWS Provided?	N/A
N/A	Landing Width (in)	N/A	N/A	DWS Contrast?	N/A
N/A	Landing Slope (%)	N/A	N/A	DWS Length (in)	N/A
N/A	Landing X Slope (%)	N/A	N/A	DWS Full Width?	N/A
N/A	Landing Curb? (Y/N)	N/A	N/A	DWS Offset (in)	N/A
N/A	Shared Landing?	N/A			
N/A	Gutter Ponding?	N/A	N/A	Gutter Slope (%)	N/A
N/A	Gutter Lip Ht (in)	N/A	N/A	Gutter X Slope (%)	N/A
N/A	Painted X Walk1?	No	N/A	Painted X Walk2?	N/A
	X Walk 1 Direction	To E		X Walk 2 Direction	N/A
N/A	X Walk 1 Width (in)	N/A	N/A	X Walk 2 Width (in)	N/A
	X Walk 1 Slope (%)	9.1		X Walk 2 Slope (%)	N/A
	X Walk 1 X Slope (%)	4.1		X Walk 2 X Slope (%)	N/A

N/A	Ramp inside XWalk1?	N/A	N/A	Ramp inside XWalk2?	N/A
	Road Slope (%)	N/A	N/A	Clear Space?	N/A
	Road X Slope (%)	N/A	N/A	Clear Space to XWalk (in)	N/A
N/A	Any Obstructions?	N/A	N/A	Storm Grate/Utility Hazard?	N/A
	Obstruction Type			Storm Grate/Utility Type	
		N/A			N/A
			Yes	Surface Condition? (G/P)	Good

**Remove & Replace Entire Ramp.**

**Not Found, R304.5.1, R304.2.2**
