Access Compliance Report

Public Rights-of-Way

(Curb Ramps)

Intersection ID: 30470	Main Street: OWLS_PERCH_DR	Cross Street: PLANTERS_ROW_DR	Location: SW
ADA ID: AB8367D615DF	Ramp Type: Directional1	Initial Pass/Fail: Fail	Overall Compliance: No
Severity Score: 1.25			
Codes/Mitigation Info/Possible Solution		Field Measurements/Component Compliance

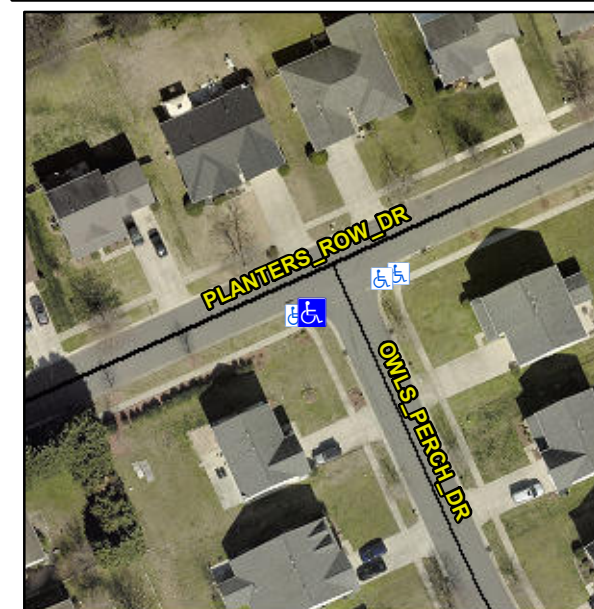
Compliance	Description	Data	Compliance	Description	Data
N/A	Ramp Length (in)	21.0	N/A	Grade Break?	N/A
Yes	Ramp Width (in)	62.0	N/A	Grade Break Slope (%)	0.0
Yes	Ramp Slope (%)	0.2	N/A	Grade Break XSlope (%)	0.0
No	Ramp XSlope (%)	4.0			
N/A	Flare Type LT	N/A	N/A	Flare Type RT	N/A
N/A	Flare Slope LT (%)	N/A	N/A	Flare Slope RT (%)	0.0
N/A	Flare Traversable LT?	N/A	N/A	Flare Traversable RT?	N/A
N/A	Landing Length (in)	0.0	N/A	DWS Provided?	N/A
N/A	Landing Width (in)	0.0	N/A	DWS Contrast?	N/A
N/A	Landing Slope (%)	0.0	N/A	DWS Length (in)	N/A
N/A	Landing X Slope (%)	0.0	N/A	DWS Full Width?	N/A
N/A	Landing Curb? (Y/N)	N/A	N/A	DWS Offset LT (in)	N/A
N/A	Shared Landing?	N/A	N/A	DWS Offset RT (in)	N/A
N/A	Gutter Ponding?	0.0	N/A	Gutter Slope (%)	N/A
N/A	Gutter Lip Ht (in)	0.0	N/A	Gutter X Slope (%)	N/A
N/A	Painted X Walk1?	No		Road Slope (%)	2.7
	X Walk 1 Direction	To NE		Road X Slope (%)	0.3
	X Walk 1 Width (in)	N/A		Clear Space?	N/A

X Walk 1 Slope (%)	2.7	N/A	Clear Space to XWalk (in)	N/A
	X Walk 1 X Slope (%)	0.3	N/A	Storm Grate/Utility Hazard?	N/A
N/A	Ramp inside XWalk1?	N/A		Storm Grate/Utility Type	
N/A	Any Obstructions?	N/A			N/A
	Obstruction Type		Yes	Surface Condition? (G/P)	Good
			N/A	Curb Slope (%)	4.6

Possible Solutions:

Remove & Replace Entire Ramp.

R304.5.3

\$ 1600.00
