Access Compliance Report Public Rights-of-Way (Curb Ramps)

Intersection ID: 10024242 Main Street: COY CT **Cross Street: N/A** Location: S **Overall Compliance: No** ADA ID: ABD62B43AF39 Ramp Type: Perp Initial Pass/Fail: Fail **Severity Score:** 8.75

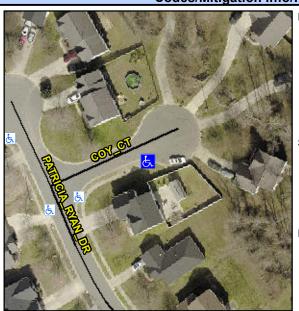
8	Possible Solutions:					
No. of Lot	Remove & Replace Entire Ramp.					
1						
The Party of	Surveyor Notes:					
4	N/A					
1	PROW/ADA:					
*	R304.5.1					
1						
36
