Access Compliance Report

Public Rights-of-Way (Curb Ramps)

Intersection ID: 3723	Main Street: PARKER_GREEN_TL	Cross Street: TRADITION_VIEW_DR	Location: S
ADA ID: ABD91DCCB2F6	Ramp Type: Perp	Initial Pass/Fail: Fail	Overall Compliance: No
Severity Score: 55			
Codes/Mitigation Info/Possible Solution		Field Measurements/Component Compliance

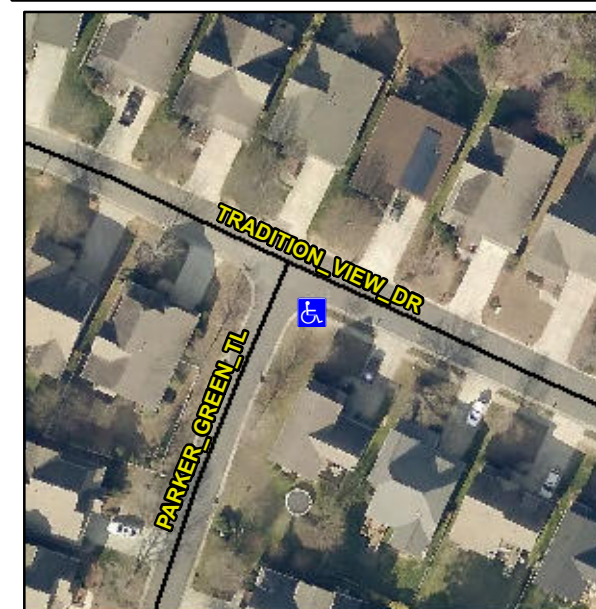
Not Found, R304.5.1, R304.2.2, R304.5.3

Compliance	Description	Data	Compliance	Description	Data
N/A	Ramp Length (in)	96.0	No	Ramp Slope (%)	9.7
No	Ramp Width (in)	32.0	No	Ramp XSlope (%)	9.3
N/A	Flare Type LT	N/A	N/A	Flare Type RT	N/A
N/A	Flare Slope LT (%)	N/A	N/A	Flare Slope RT (%)	N/A
N/A	Flare Traversable LT?	N/A	N/A	Flare Traversable RT?	N/A
N/A	Landing Length (in)	N/A	N/A	DWS Provided?	N/A
N/A	Landing Width (in)	N/A	N/A	DWS Contrast?	N/A
N/A	Landing Slope (%)	N/A	N/A	DWS Length (in)	N/A
N/A	Landing X Slope (%)	N/A	N/A	DWS Full Width?	N/A
N/A	Landing Curb? (Y/N)	N/A	N/A	DWS Offset (in)	N/A
N/A	Shared Landing?	N/A			
N/A	Gutter Ponding?	N/A	N/A	Gutter Slope (%)	N/A
N/A	Gutter Lip Ht (in)	N/A	N/A	Gutter X Slope (%)	N/A
N/A	Painted X Walk1?	No	N/A	Painted X Walk2?	N/A
	X Walk 1 Direction	To NW		X Walk 2 Direction	N/A
N/A	X Walk 1 Width (in)	N/A	N/A	X Walk 2 Width (in)	N/A
	X Walk 1 Slope (%)	1.2		X Walk 2 Slope (%)	N/A
	X Walk 1 X Slope (%)	5.6		X Walk 2 X Slope (%)	N/A

Remove & Replace Entire Ramp.
