Access Compliance Report

Public Rights-of-Way

(Curb Ramps)

Intersection ID: N/A	Main Street: MCCLINTOCK_RD	Cross Street: BASCOM_ST	Location: SW
ADA ID: ABDB8253B76A	Ramp Type: Perp	Initial Pass/Fail: Fail	Overall Compliance: No
		Severity Score: 12.5

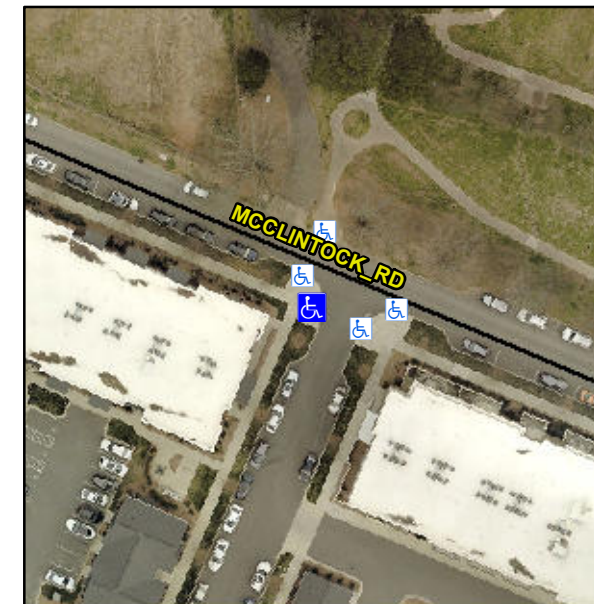
Compliance	Description	Data	Compliance	Description	Data
N/A	Ramp Length (in)	130.0	No	Ramp Slope (%)	9.4
Yes	Ramp Width (in)	48.0	Yes	Ramp XSlope (%)	1.1
N/A	Flare Type LT	N/A	N/A	Flare Type RT	N/A
N/A	Flare Slope LT (%)	N/A	N/A	Flare Slope RT (%)	N/A
N/A	Flare Traversable LT?	N/A	N/A	Flare Traversable RT?	N/A
N/A	Landing Length (in)	N/A	N/A	DWS Provided?	N/A
N/A	Landing Width (in)	N/A	N/A	DWS Contrast?	N/A
N/A	Landing Slope (%)	N/A	N/A	DWS Length (in)	N/A
N/A	Landing X Slope (%)	N/A	N/A	DWS Full Width?	N/A
N/A	Landing Curb? (Y/N)	N/A	N/A	DWS Offset (in)	N/A
N/A	Shared Landing?	N/A			
N/A	Gutter Ponding?	N/A	N/A	Gutter Slope (%)	N/A
N/A	Gutter Lip Ht (in)	N/A	N/A	Gutter X Slope (%)	N/A
N/A	Painted X Walk1?	No	N/A	Painted X Walk2?	N/A
	X Walk 1 Direction	To E		X Walk 2 Direction	N/A
N/A	X Walk 1 Width (in)	N/A	N/A	X Walk 2 Width (in)	N/A
	X Walk 1 Slope (%)	2.1		X Walk 2 Slope (%)	N/A
	X Walk 1 X Slope (%)	2.4		X Walk 2 X Slope (%)	N/A

N/A	Ramp inside XWalk1?	N/A	N/A	Ramp inside XWalk2?	N/A
	Road Slope (%)	N/A	N/A	Clear Space?	N/A
	Road X Slope (%)	N/A	N/A	Clear Space to XWalk (in)	N/A
N/A	Any Obstructions?	N/A	N/A	Storm Grate/Utility Hazard?	N/A
	Obstruction Type			Storm Grate/Utility Type	
		N/A			N/A
			Yes	Surface Condition? (G/P)	Good

Remove & Replace Entire Ramp.

R304.2.2

\$ 1850.00
